# APPLICATION NOTE

## Effective off-line machine fault detection and diagnosis at the Tabriz Petrochemical Complex

### Case Study - Multiple faults

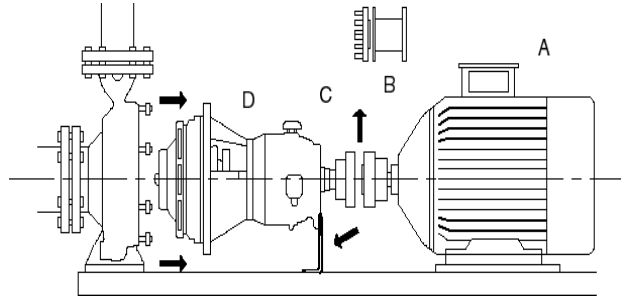
Fig. 1 Motor-driven centrifugal pump in water pre-treatment plant

A 55kW motor-driven centrifuge pump (2985 rpm) in the water pre-treatment plant is off-line monitored once a month.

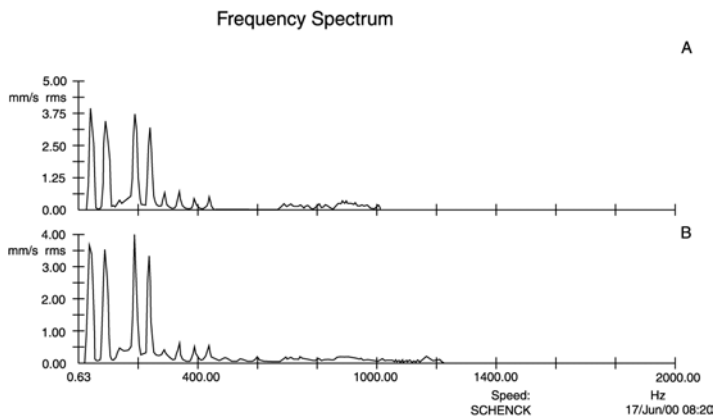
For several months the vibration velocity rms value for this pump was within the VDI 2056 limits (maximum of 1.98 mm/s), but during a routine monitoring round, there was a sudden increase to 7.8 mm/s. Diagnostic measurements were then immediately done using FFT spectra and BCS (bearing condition signature/selective envelope detection) to find out the cause of the high vibrations.

It was immediately obvious that there was severe misalignment by looking at the first few harmonics in Fig. 2. Although not apparent because of the plot scaling, there was also indication in the plot that something was wrong with the coupling as shown by the increased vibration energy in the 600 to 1000 Hz range.

Investigations revealed that a 2" line was welded from the suction end of the pump to discharge header to satisfy process requirements two weeks earlier. This caused piping strain that misaligned the shaft and later damaged the coupling. If this

*Fig. 2 Spectrum at point C (in Fig. 1) before alignment*

A work order was issued to Maintenance to immediately align the pump shaft and check the condition of the coupling. An envelope spectra suggested that although there was severe misalignment, there was no apparent consequential damage to the rolling-element bearings so these did not have to be replaced or even checked.

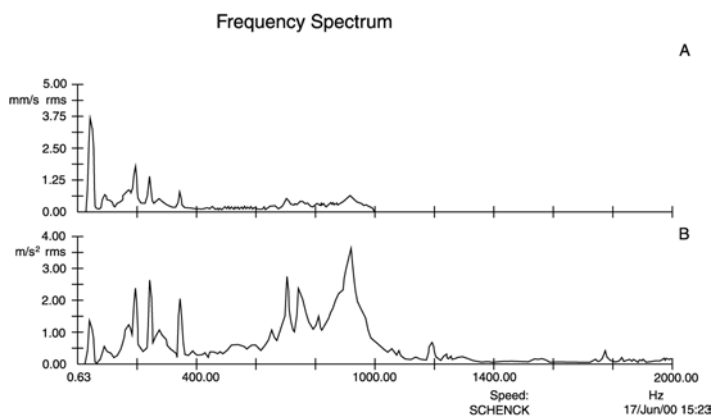
The Maintenance group quickly corrected the misalignment, but put the pump back into operation without checking the coupling. Shaft vibrations were less after measurements were done again (from 7.8 mm/s to 3.2 mm/s), but this was still too high for this particular pump. FFT spectra was done afterwards (Fig. 3) and indicated the misalignment problem had been corrected but there were still high vibrations at the coupling frequencies.

*Fig. 3 Spectrum at point C (in Fig. 1) after alignment*

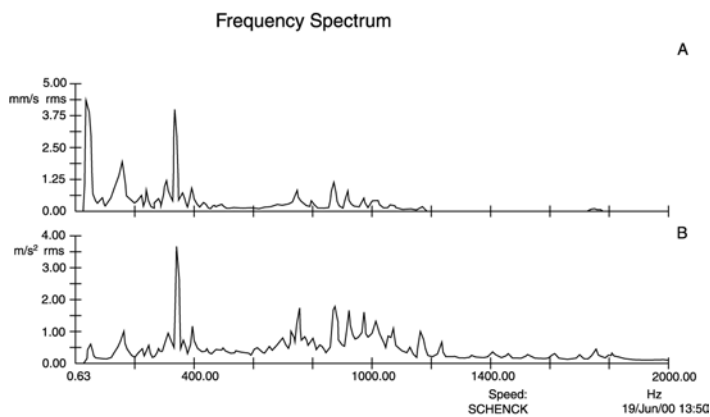
After disassembly, it was observed that rubber pads of the coupling were damaged. After replacement, measurements were done again and the overall vibration decreased to 1.8 mm/s, which was acceptable. The FFT measurements also looked better (Fig. 4). Although the pump was now fully operational, further investigation was still needed to

*Fig. 4 Spectrum at point C (in Fig. 1) after replacing new rubber pads*
