Application Note

**Case study – Effective off-line
machine fault detection and
diagnosis at the Tabriz
Petrochemical Complex**

Case study - Multiple faults

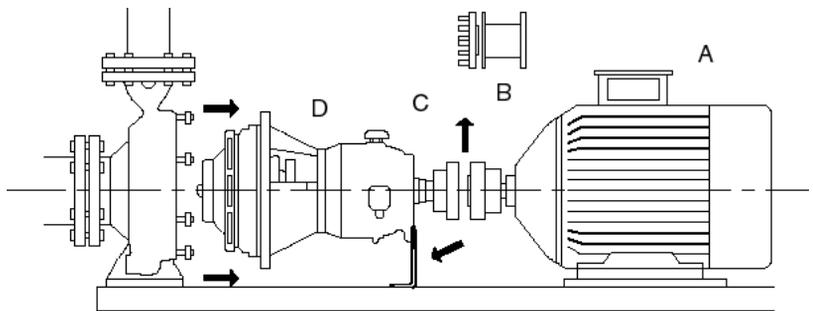
A 55kW motor-driven centrifuge pump (2985 rpm) in the water pre-treatment plant is off-line monitored once a month.

Figure 1. Motor-driven centrifugal pump in water pre-treatment plant.

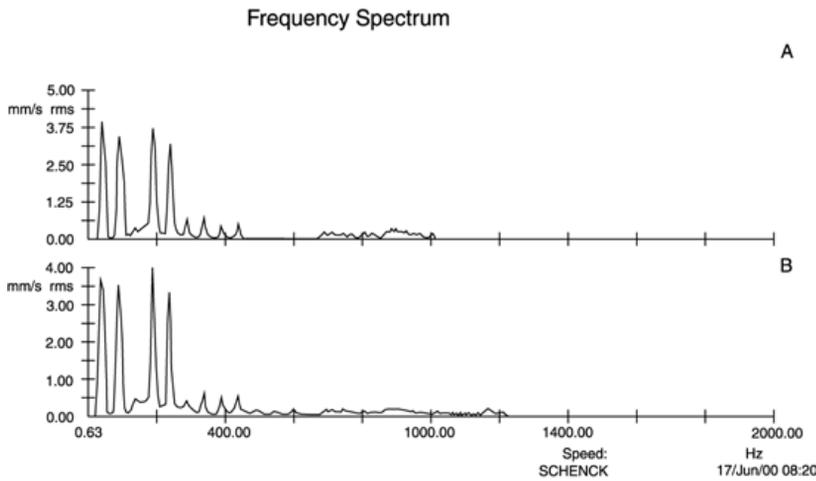
For several months the vibration velocity RMS value for this pump was within the VDI 2056 limits (maximum of 1.98 mm/s), but during a routine monitoring round, there was a sudden increase to 7.8 mm/s. Diagnostic measurements were then immediately done using FFT spectra and BCS (bearing condition signature/selective envelope detection) to find out the cause of the high vibrations.

It was immediately obvious that there was severe misalignment by looking at the first few harmonics in Figure 2. Although not apparent because of the plot scaling, there was also indication in the plot that something was wrong with the coupling as shown by the increased vibration energy in the 600 to 1000 Hz range.

Investigations revealed that a 2” line was welded from the suction end of the pump to discharge header to satisfy process requirements two weeks earlier. This caused piping strain that misaligned the shaft and later damaged the coupling. If this situation was not corrected in time, severe damage could have occurred to the motor and/or pump that could have resulted in both lost production and expensive spares. Since this problem was corrected, the pump has been functioning well the last eight months.

Figure 2. Spectrum at point C (in Figure 1) before alignment.

A work order was issued to Maintenance to immediately align the pump shaft and check the condition of the coupling. An envelope spectra suggested that although there was severe misalignment, there was no apparent consequential damage to the rolling-element bearings so

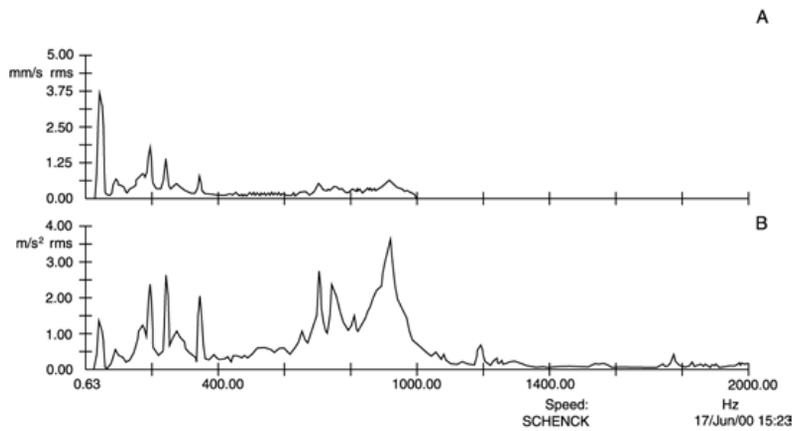
The Maintenance group quickly corrected the misalignment, but put the pump back into operation without checking the coupling. Shaft vibrations were less after measurements were done again (from 7.8 mm/s to 3.2 mm/s), but this was still too high for this particular pump. FFT spectra was done afterwards (Figure 3) and indicated the misalignment problem had been corrected but there were still high vibrations at the coupling frequencies.

Figure 3. Spectrum at point C (in Figure 1) after alignment.

After disassembly, it was observed that rubber pads of the coupling were damaged. After replacement, measurements were done again and the overall vibration decreased to 1.8 mm/s, which was acceptable. The FFT measurements also looked better (Figure 4). Although the pump was now fully operational, further investigation was still needed to determine what caused the misalignment and damaged coupling.

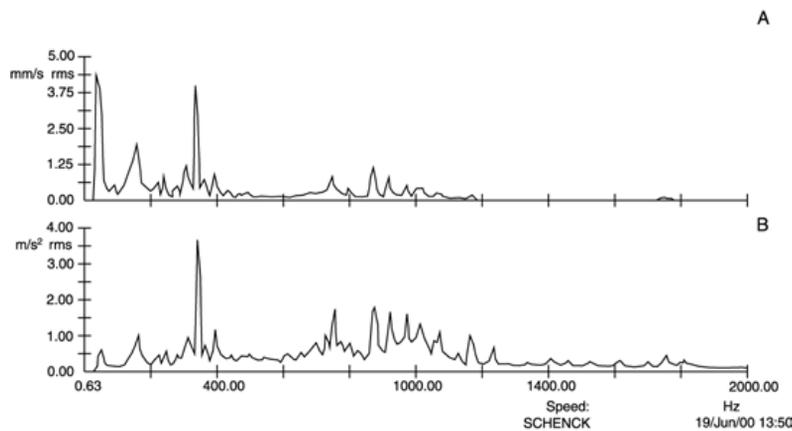
Figure 4. Spectrum at point C (in Figure 1) after replacing new rubber pads.
