# Application Note

## Detecting, diagnosing and correcting for compressor surge at a petrochemical plant

### Olefin, polyolefin petrochemical plant

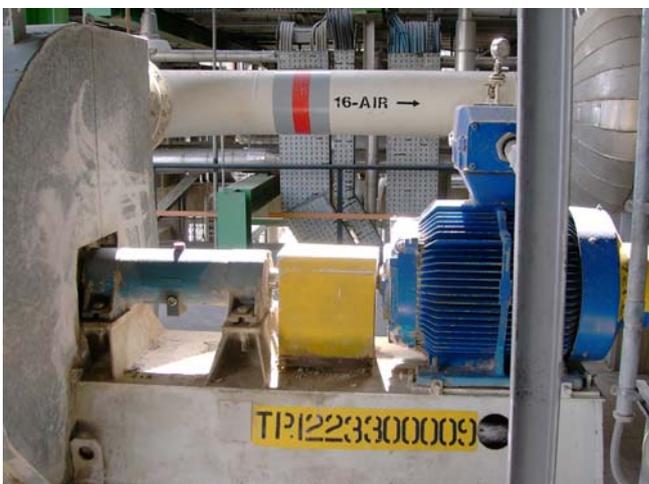
It is a critical non-spared machine so all downtime results in lost production. Despite the monthly liquid penetrant testing, a piece of the impeller detached itself one day and destroyed the impeller and bearing housing, which also seriously damaged the compressor case and motor. This resulted in six days downtime.

Fig. 1 Air compressor for the polyethylene line

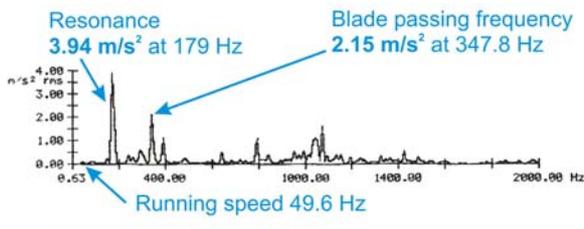
It was at this time the Vibroport 41 vibration analyzer was purchased and played an important role in finding the root cause of the problem. Unusually high radial vibrations in the upper frequency range plus high axial vibrations were detected using this instrument. These vibrations coupled with the abnormal noise of the compressor plus the high bearing temperatures gave an indication of compressor surge. The excessive vibrations caused by this flow disturbance also excited resonant frequencies of structural components and ultimately led to excessive loading and fatigue on the impeller and bearings.

Fig. 2 Radial vibration spectrum from motor foundation showing an asynchronous peak that is presumably caused by a natural frequency excited by surge.

It was later determined that the cause of the surge was due to the fact that the compressor was over-designed for the application. The inlet guide vanes were normally open only 20% in order to avoid too much airflow into the process. This adversely affected the performance of the compressor and caused it to surge, which in return caused the

impeller cracks and premature failure of the bearings.

The most cost-effective solution was decided to reduce the impeller diameter from 118 cm to 109 cm, as determined by thermodynamic calculations. This solved the problem! As seen in Figures 4 and 5, this reduced the resonances and vibrations caused by the surge.

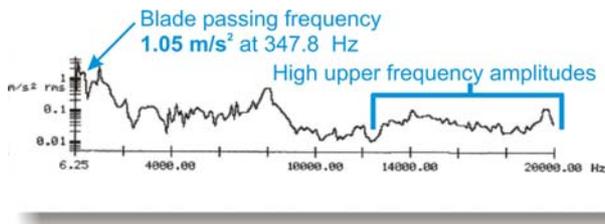
Fig. 3 Compressor bearing radial vibration spectrum showing upper frequency vibration caused by surge.

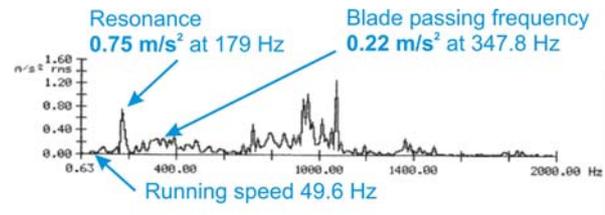
Fig. 4 After repair: Radial vibration spectrum from motor foundation showing the non-synchronous natural frequency peak and blade passing frequency have reduced or vanished in relation to Fig. 2.
