CASE STUDY

Detection of High-Speed Coupling Looseness

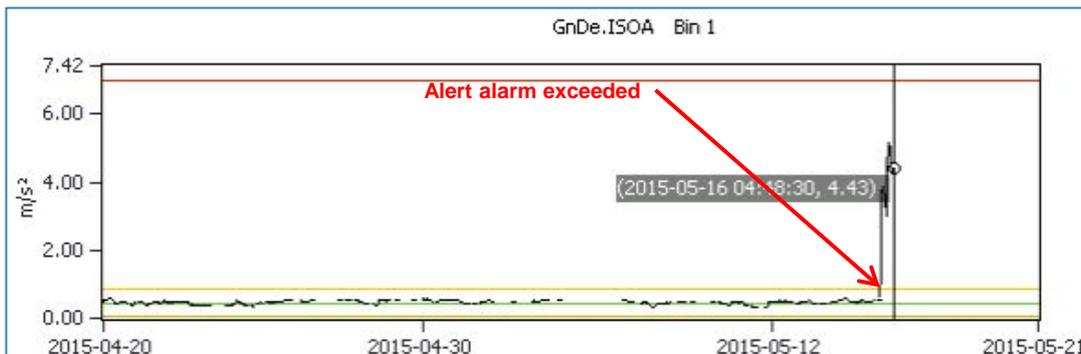
The alert alarm limit was exceeded on both sides of the high-speed coupling of the wind turbine, as shown in Figures 2-3. The Brüel & Kjær Vibro Diagnostic Group was automatically informed and took immediate action to evaluate the situation, as the vibration levels were rising rapidly.

Figure 2: The vibration amplitude suddenly increases on the generator side of the coupling up until shutdown. (Discontinuity of the trend is due to measurements being displayed only for a specific power class.)

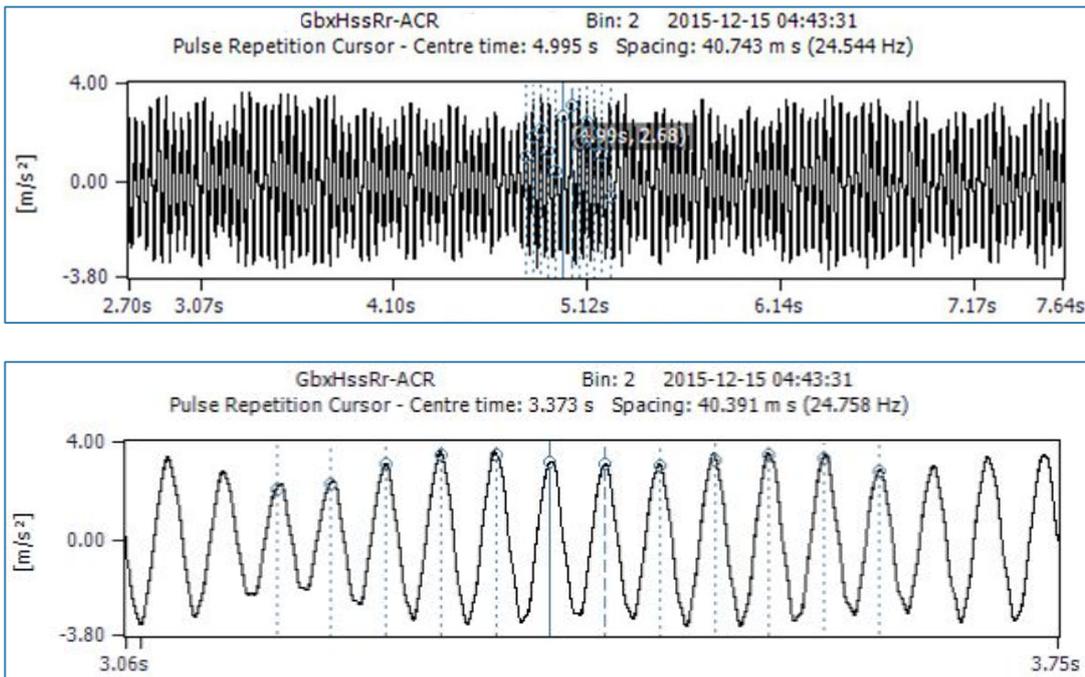
The Brüel & Kjær Vibro Diagnostic Group quickly analyzed the alarm situation and determined the fault was a defective high-speed coupling, as shown in Figure 4.

Figure 4: Filtered time signal, recorded immediately after the alarm (zoom shown on the bottom). The high amplitude of a specific frequency that corresponds to the generator speed indicates a fault in the high-speed coupling.

After identifying the coupling fault and its severity, the Diagnostic Group immediately issued a Severity 1 Alarm report (the highest severity) to the customer, who was also contacted by phone. The report recommended the following to the maintenance crew:

- Subject: Gearbox High Speed Stage – composite coupling defect
- Action required immediately
- It is recommended to stop the turbine to inspect the coupling between High Speed Stage and the Generator
- Provide feedback to bkvcmb@bkvibro.com after the maintenance work has been carried out

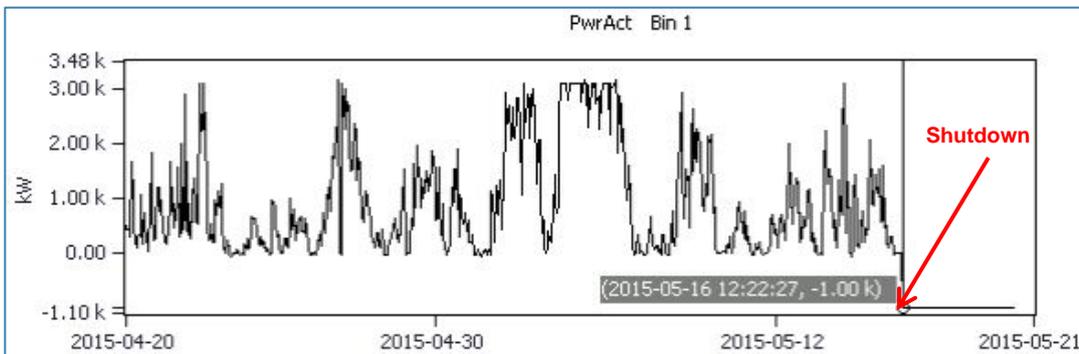
Figure 3: Active power generated by the same wind turbine up until shutdown.

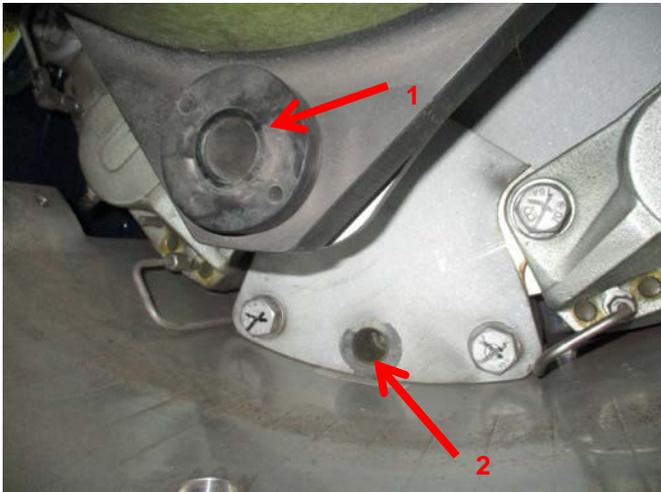
As recommended by the alarm report, the wind turbine was stopped immediately by the customer and a site inspection was done the next day. Figures 5-7 show the results of this site inspection. It was determined that two of the coupling bolts had loosened themselves free, most likely due to incorrect torque settings.

Figure 7: Location of the two bolts that were loosened free due to vibration:

1. One of the two coupling bracket bolts on gearbox side
2. One of the bolts between the disc brake calipers

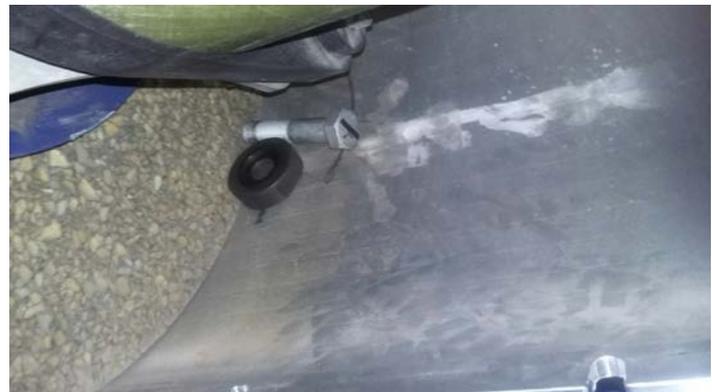
Figure 5: A coupling bracket bolt was found inside the coupling shield.

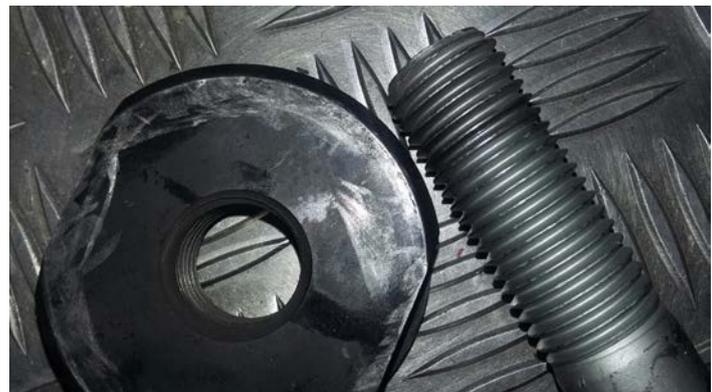
Figure 6: One of the bolts between the disc brake calipers was found lying on the floor plate

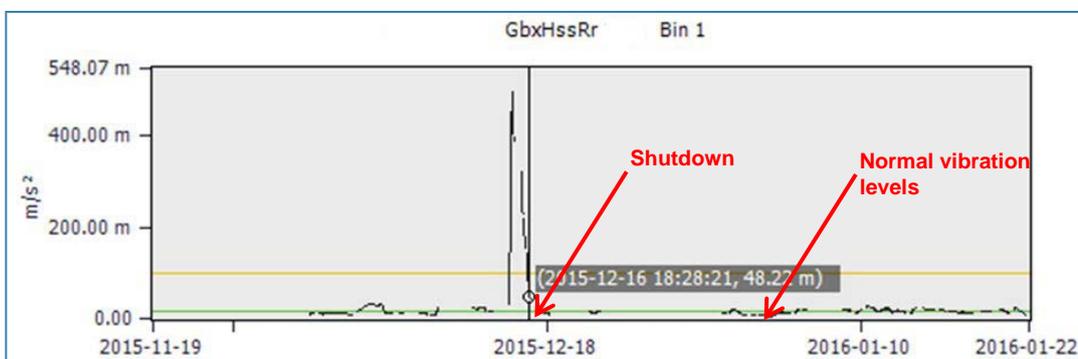
Figure 8: Vibration amplitude levels after the two coupling bolts were replaced and all bolts were properly torqued.

Figure 8 shows the vibration levels of the high-speed coupling after the coupling bolts were replaced and all the bolts properly torqued.
