CMS Alarm Report – Potential Fault and Technical Advice

Site/Park ID:	Zephyr	Main Bearing:	
WTG No:	20200	Gearbox:	CBG100TE55
WTG Type:	CA100-3000 50 Hz	Generator:	ELGA
Tag:	Zephyr#02	RML No:	RML1001207Q-00

Zephyr#02, 16/01/10 06:08:51 High Speed Stage Front Preliminary Severity Class 2

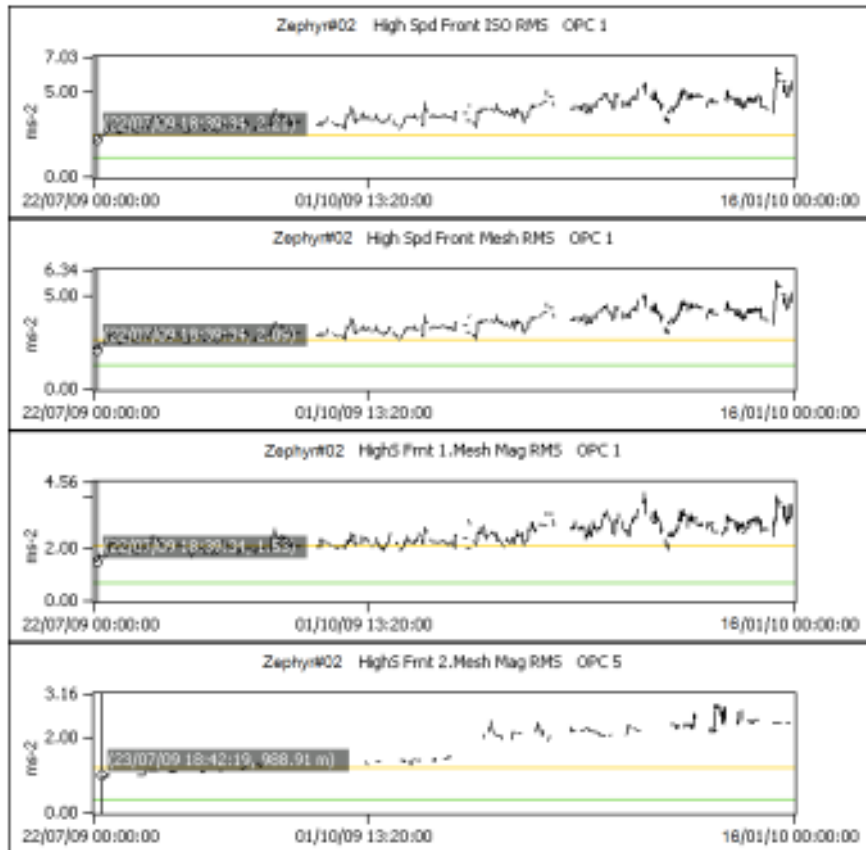
Continuing progressive increase in Gearbox HS Front and HS Rear Overall Vibration level above Alert limit.
Continuing progressive increase in Gearbox HS Front and HS Rear 1st & 2nd Mesh vibration above Alert limit

No significant change in Gearbox HS Front and HS Rear 3rd Mesh vibration.
Continuing progressive increase in Intermediate Stage Gearbox 1st & 2nd Mesh vibration.
No significant change in 1st or 2nd Magnitude vibration levels.
No change in Intermediate or HS Front and HS Rear Gearbox High Frequency Band Pass (HFBP) vibration.

The progressive increase in Gearbox Intermediate and HS Front and HS Rear 1st & 2nd Mesh vibration indicates a general deterioration in the condition of the Intermediate and High Speed stage gear teeth. The vibration levels are currently acceptable and do not give immediate cause for concern, but are progressively deteriorating.

The Gearbox Intermediate and High Speed stages should be visually inspected as soon as possible. Particular attention should be paid to the condition of the Intermediate output pinion gear teeth. BKV will close monitor the Gearbox to identify any further deterioration.

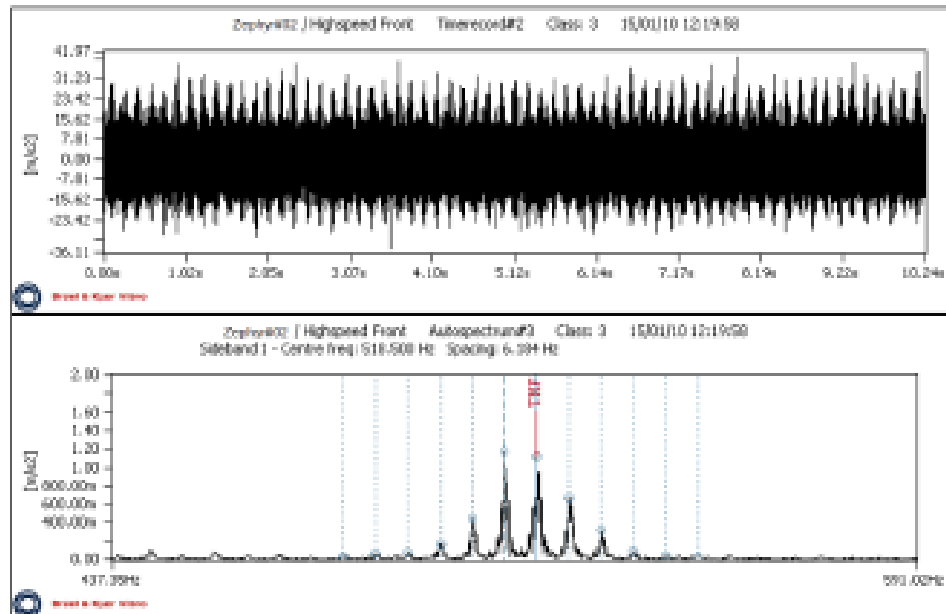
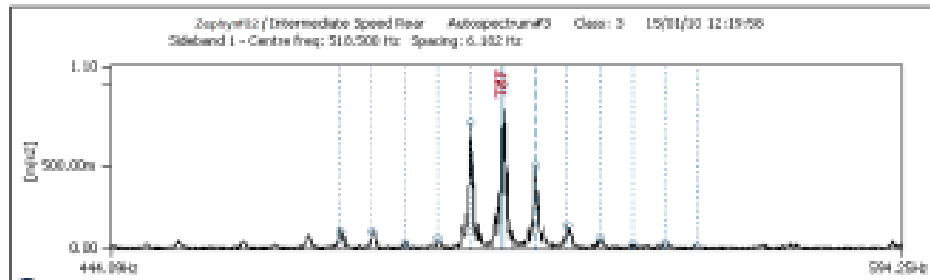
Detailed analysis has shown the presence of significant sidebands around the High Speed Stage Toothmesh frequency. The sidebands are at the Intermediate Shaft speed (6.184Hz) indicating that the damage is on the Intermediate Shaft output pinion.

Due the presence and relative size of the Toothmesh Sidebands the alarm is confirmed as Severity 2.
