Application Note

Case study – Compass 6000™ detected a fault that avoided unnecessarily disassembling a pump in Europe's largest pumping station

ABSTRACT

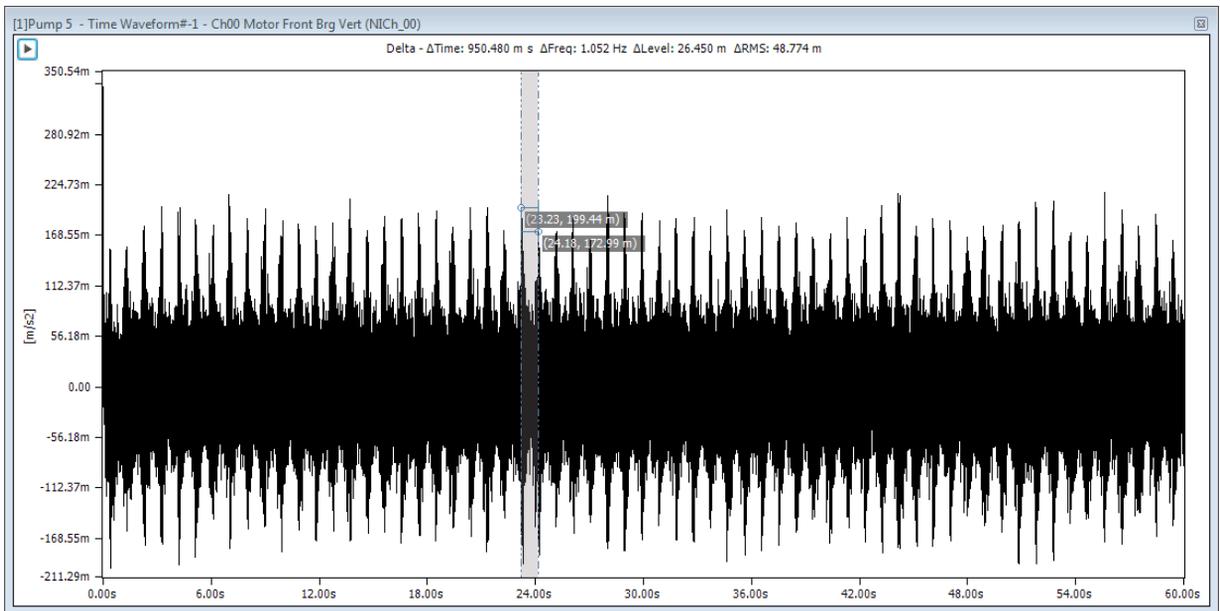
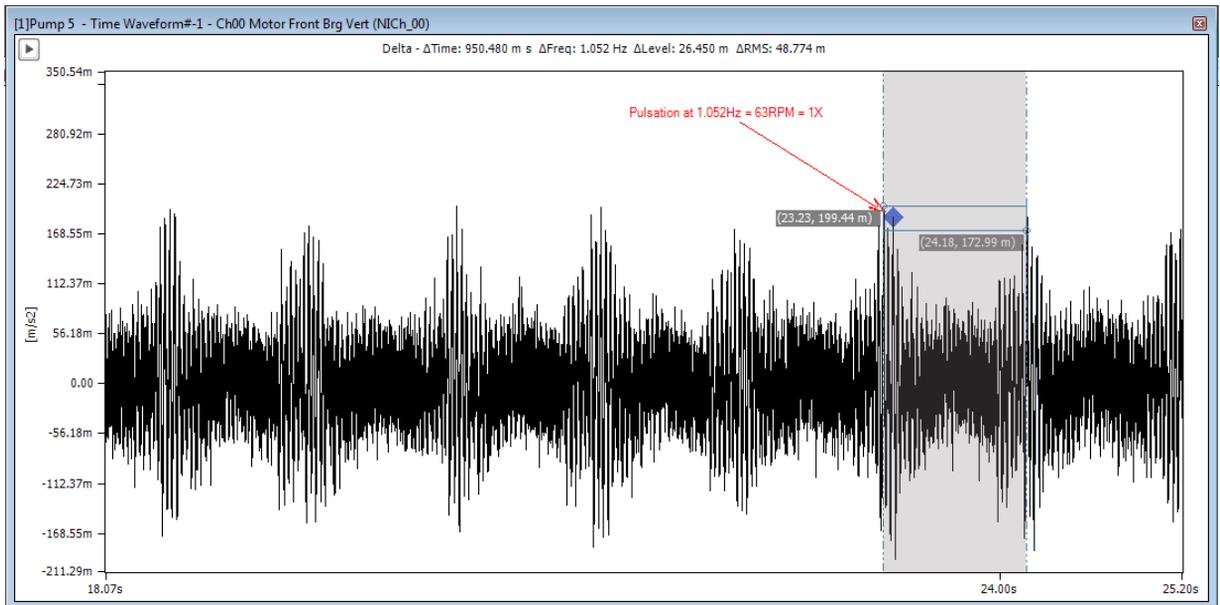
A once per revolution vibration spike was observed, together with a significant 2x line frequency component. An eccentric rotor, which results in variable air gap, can present similar symptoms, but this condition was regarded as unlikely. The pump had operated flawlessly for 11 years and the bearings are press fit so there is minimal risk of assembly errors. Moreover, the spike disappeared when the power was removed while the rotor was still turning at 60 RPM.

Figure 5. Time signal measurements are shown from the front bearing of the pump (similar signal for the rear bearing). The bottom picture is a zoom from the upper one. The once per revolution spikes are clearly seen.

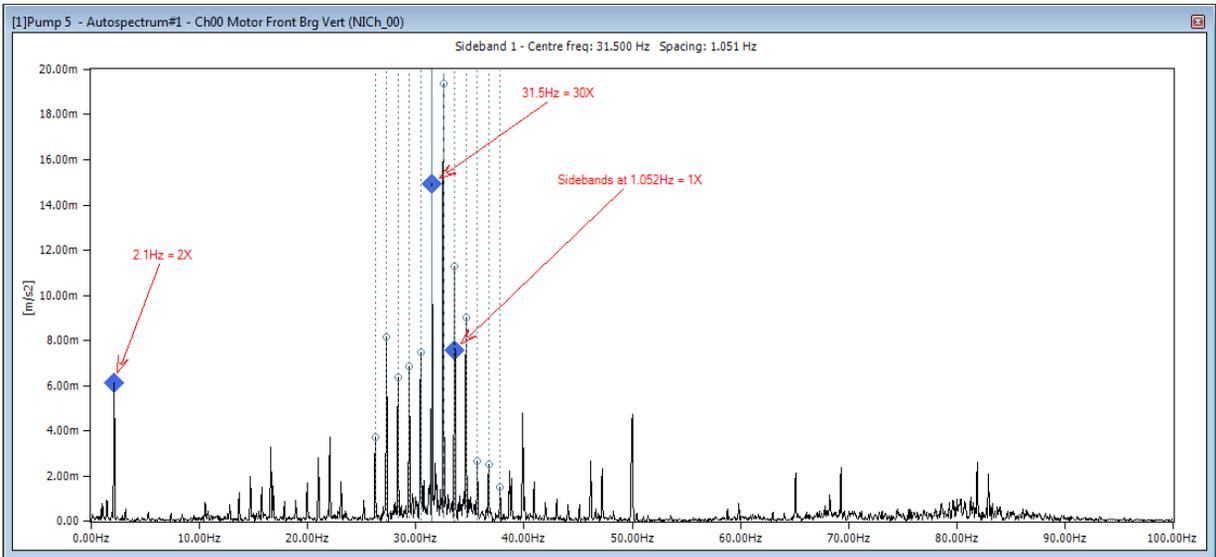
Figure 6. Spectrum from the front bearing (rear bearing similar). The 30x harmonic (not a known frequency, neither blade related) has been amplitude modulated to the running speed of the pump, resulting in strong sideband activity. The 2x harmonic has also increased significantly.

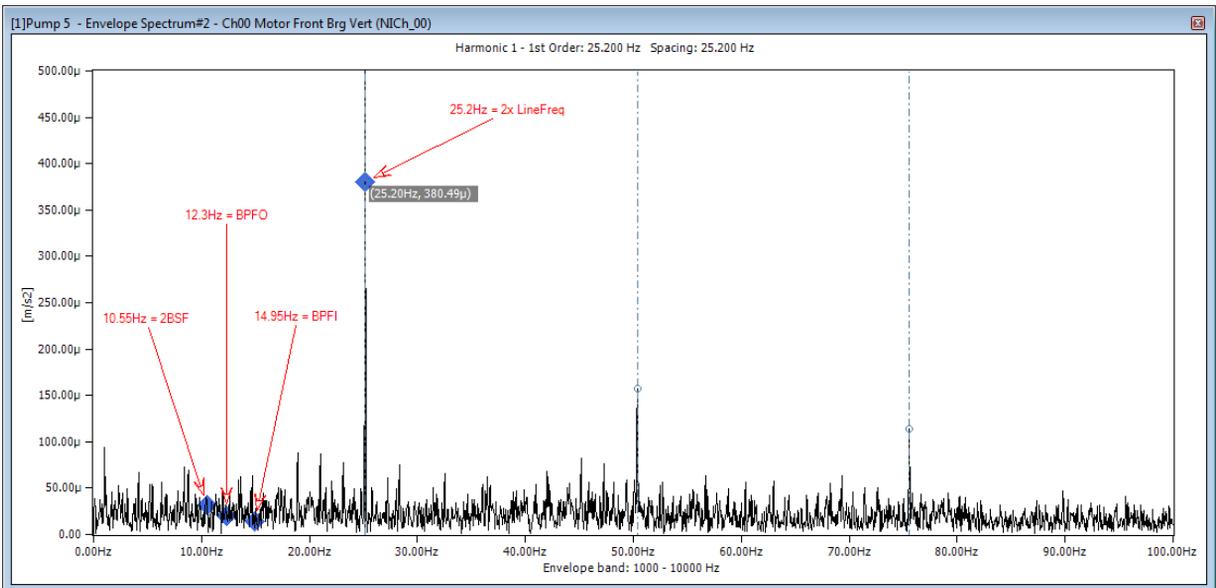
Figure 7. Envelope spectrum shows no evidence of bearing fault frequencies of the front bearing (similar to the rear bearing) but there is a high 2x frequency component, which is often an indicator of an electrical problem. (BPFO = outer race defect, BPFI = inner race defect, 2BSF = ball/roller defect).

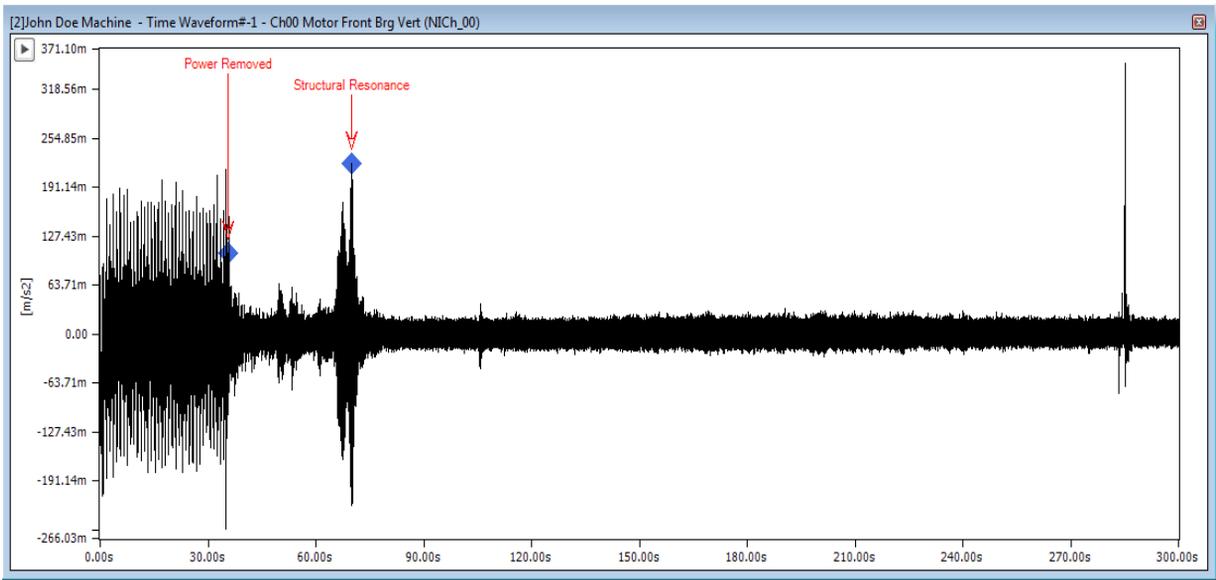
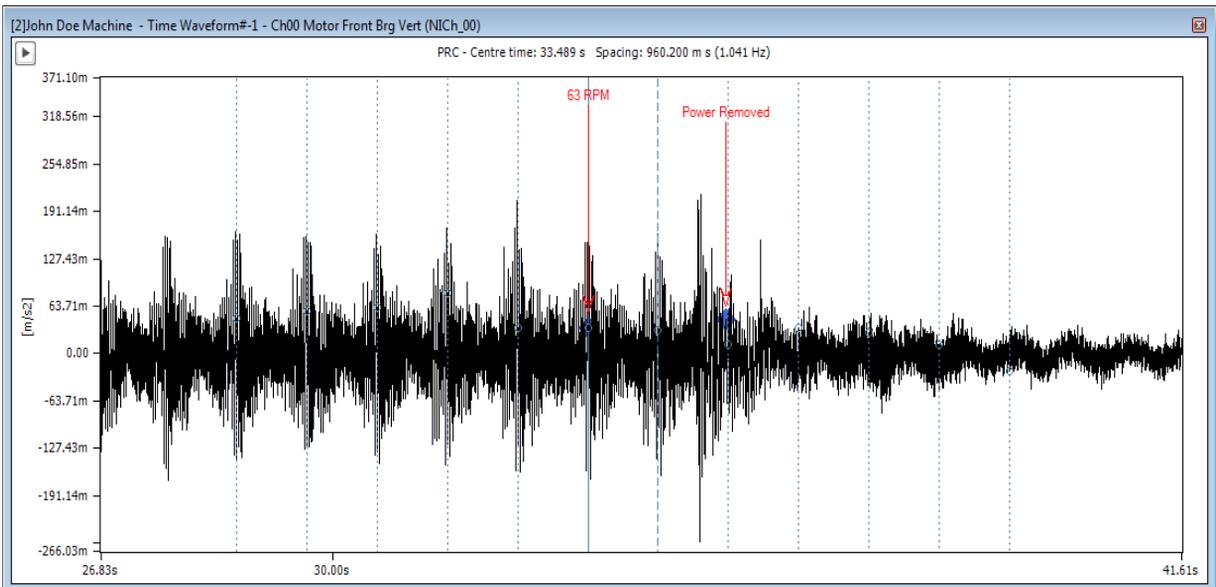
Figure 8. Coast down time signal plots of the front bearing (rear bearing similar). Lower plot is a zoom of the upper plot. The spikes disappear when the power is removed, suggesting an electrical fault.

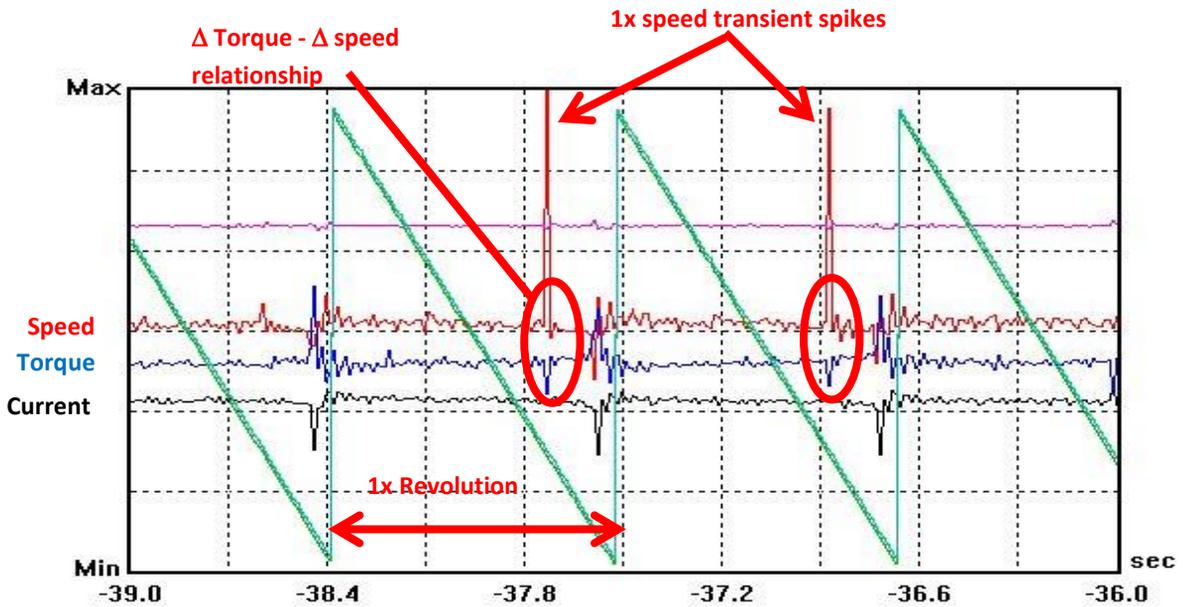
The conclusion from analyzing the measurements shown in Figures 5-9 was that the once per revolution vibration spike was not due to the condition of the pump or its machine components, but due to a problem with the variable speed drive system and/or the rotary encoder. Once this diagnosis was made, it was determined that it was not necessary to disassemble the pump to investigate the cause of the vibration spike, thus avoiding unneeded downtime and maintenance. Only the VSD and/or rotary encoder needed to be investigated and corrected. Moreover, since the detection and diagnosis of this problem was performed shortly after re-commissioning, the pump rotor and motor components were not unnecessarily subjected to spurious loading for a period of time. Once again, Brüel & Kjær Vibro diagnostics added value to a customer in need.

Figure 9. Signals from the VSD/encoder system showing speed, motor torque and motor current. A transient spike appears on the calculated motor speed every revolution. Each spike represents up to a 5 RPM instantaneous change in speed for every revolution. This incorrect speed transient forces the VSD to try to compensate, as seen by the torque measurement.
