CASE STUDY

Detection and Diagnosis of a Slip Ring Fault of a Wind Turbine DFIG

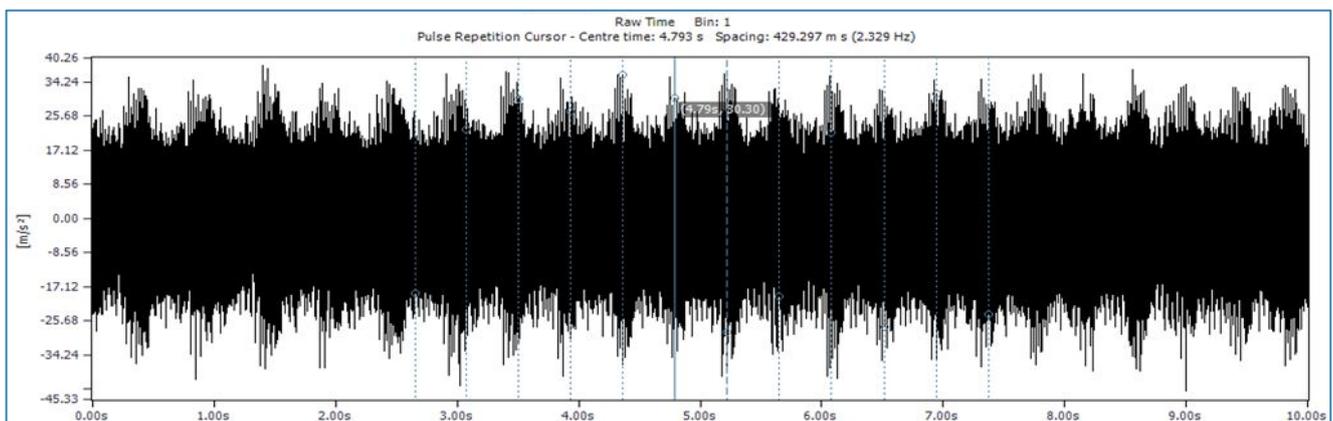
The Brüel & Kjær Diagnostics Group analyzed the data using a detailed time waveform and frequency spectrum, as shown in Figures 1-2. Increased vibration indicated a potential problem with generator slip ring unit.

Figure 1: The time waveform showing amplitude modulation of a little less than 2.5 Hz.

- Generator inspection is recommended within 1-2 weeks.
- It is recommended to perform an up-tower generator test run with particular focus on the slip ring unit. Check the height of the slip ring brushes to be within the acceptable limits, inspect the condition of the cooling groves, insulation ring and the current clamps.
- Provide feedback to bkvcmbk@bkvibro.com after the maintenance work has been carried out.

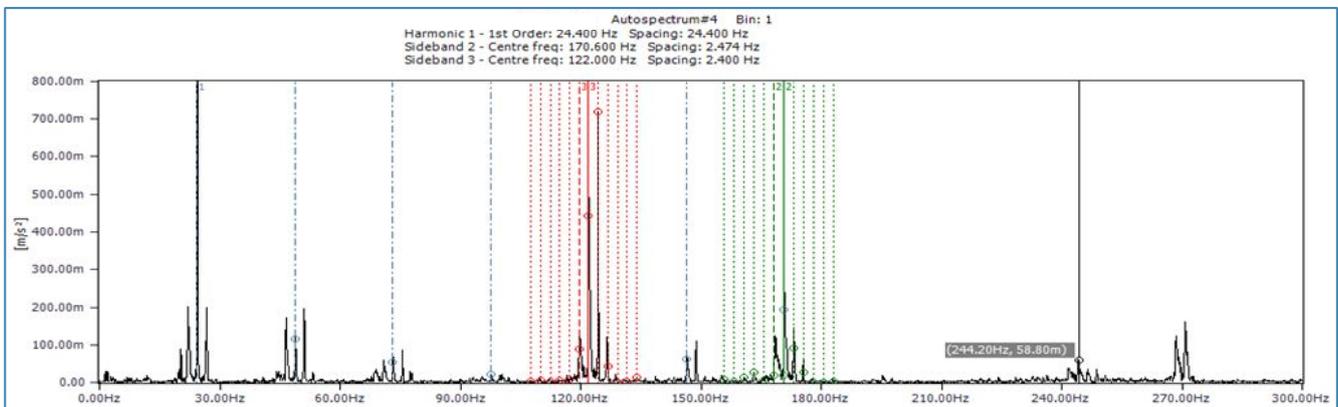
Figure 2: Increased vibration amplitude for several harmonics as measured by the accelerometer located on the non-driven end generator bearing.

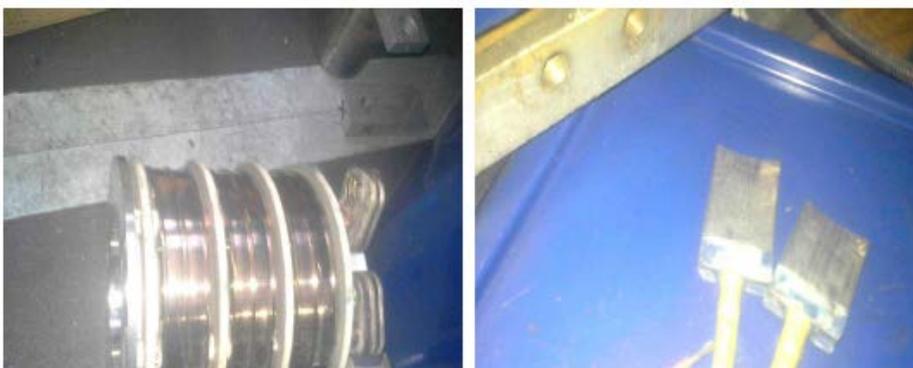
A site inspection was done one day after the report was issued.

Figure 3: Slip ring shown with worn out cooling groves (left), and worn out brushes (right).

After the slip ring unit and brushes were replaced, the wind turbine returned to production with lower vibrations measured on the generator bearings.

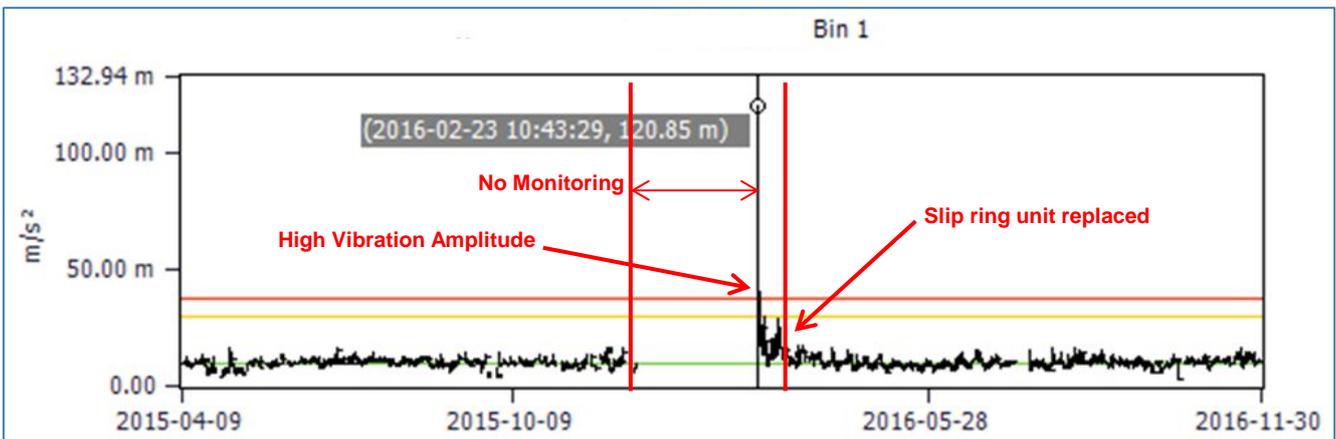
Figure 4: Vibration amplitudes returned to normal (6x harmonic shown), as measured by the accelerometer located on the non-driven end generator bearing.
