WIND TURBINE GEARBOX DEFECT

Gearbox faults are one of the major causes for wind turbine downtime. This case story demonstrates how an effective remote condition monitoring strategy avoided costly downtime and consequential damage.

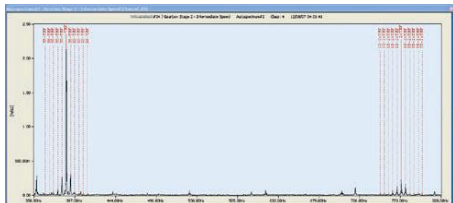
As shown in Figure 1, the gearbox second stage gear mesh frequency (first order) exceeded the Alert alarm limits. Detailed analysis shows sidebands around the first and second order gear mesh frequencies of the gearbox second stage, which confirm a gearbox fault.

Figure 2. Spectrum of the damaged second stage of the gearbox.

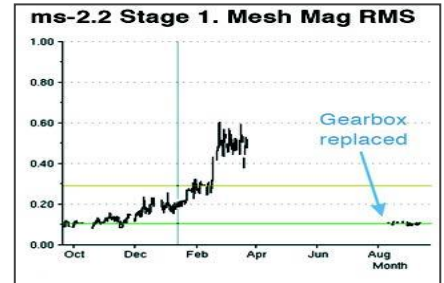
Figure 1: The trend plot showing the gear mesh frequency trend before and after servicing the gearbox.

Metal shavings, presumably from the second stage gear teeth (see Figure 3), were seen in the oil filter, so the gearbox was removed for further inspection and replaced by a new one with minimal downtime. After replacement, the reduced first order gearmesh amplitude of the new gearbox is seen in Figure 1.

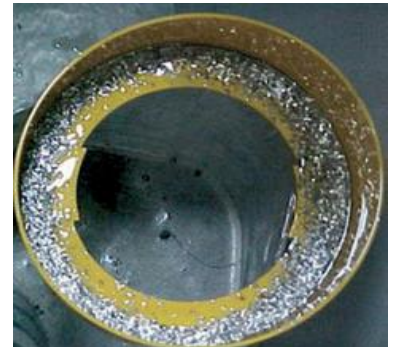
Figure 3. Metal shavings in the oil filter coming from the damaged second stage of the gearbox.
