## YAW BEARING SYSTEM FAULT DETECTED

Two case studies demonstrate how an effective remote condition monitoring strategy avoids uneconomical operation, costly downtime and consequential damage of wind turbines

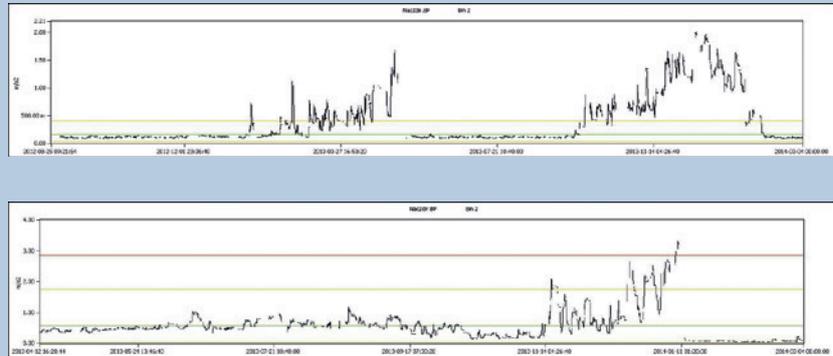
**Case 1:** The vibration descriptors of the signal from the accelerometers located on the main bearing (not shown) and on the tower (Figure 4, top) for a wind turbine exceeded the alert limits in February 2013. The overall RMS vibration signal, not shown, remained within acceptable limits. There were no faults found in the main bearing or blades, so the

spring packs on the yaw clamp assemblies were replaced and the wind turbine put back into operation in May 2013, where the vibration levels returned to normal. The vibration increased again more dramatically in September 2013.

**Case 2:** The tower accelerometers for a wind turbine at another wind park showed an immediate and abrupt change as indicated on the bottom in Figure 4, exceeding the danger alarm limits. Monitoring focus was subsequently placed on the blade/main rotor assembly, the main bearing, and the yaw bearing system.

**Figure 4.** Case 1 (top, before and after repair) and Case 2 (bottom, before and after repair): Bandpass acceleration vibration descriptors from the tower accelerometers.

**Case 1:** Both faults were a unique occurrence for the wind park. A medium severity level was initially assigned to the first fault because it was present for some time and it never exceeded the danger limits. A higher severity was assigned to the second occurrence of the fault, partly because it was more dramatic, and because it was the second time the same fault symptoms occurred. In both cases the fault development was carefully followed.

**Case 2:** A high severity was assigned to this fault because of the very rapid vibration level increase combined with the fact that the danger alarm limits were violated. This was also partly based on the experience and feedback gained from Case 1. Recommended service time was 4 weeks.

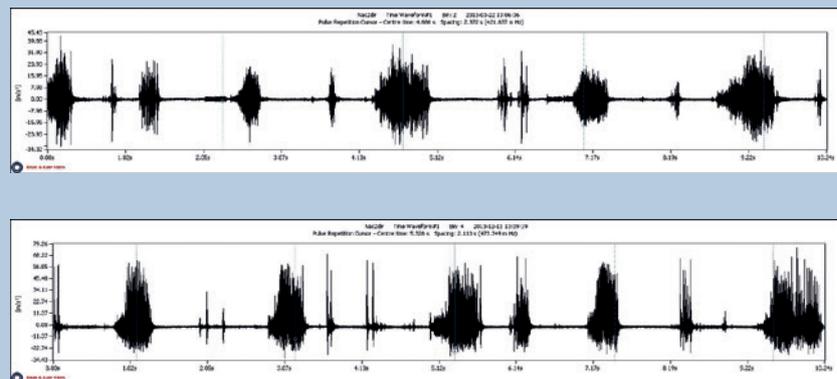
**Case 1:** At both times, in February 2013 and September 2013, there appeared to be a random impact seen in the time signal from the accelerometers on the tower (Figure 5, top) and main bearing (not shown). Because of the randomness of the impacts, it was initially difficult to pinpoint the exact cause, as the problem could be related to the blades, main bearing or the yaw bearing system. No problems were found in either the blades or the main bearing, so the yaw bearing system was suspect. The spring packs for the yaw bearing clamp assemblies were replaced in May 2013 and the high vibrations disappeared. The high vibrations returned again in September 2013 unexpectedly. Again the yaw bearing system is suspect.

**Case 2:** The time signal shown in Figure 5 (bottom) indicated a periodic impact that corresponded to two times the main rotor running speed. This periodic impact was assumed to be related to the blades and/or the yaw bearing system.

**Figure 5.** Case 1 (top) and Case 2 (bottom): A vibration impact signal is visible in both plots. For Case 1 (top) it appears random while for Case 2 it occurs twice every rotation.
