RUN LIKE CLOCKWORK

Michael Hastings, Brüel & Kjær Vibro, Denmark, explains how early detection and diagnostics of bearing manufacturing faults and improperly assembled gearboxes is vital for the smooth running of critical machines at LNG plants.

Case 1 – bearing with manufacturing fault detected on instrument air compressor

Case 2 – detection of improperly assembled gearbox of the propane compressor

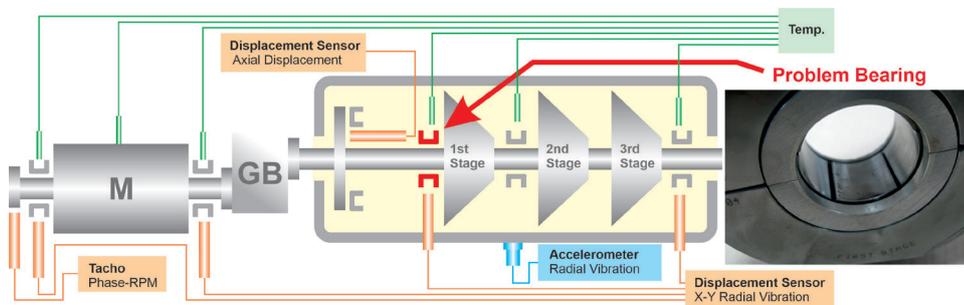
Figure 1. Sensor configuration of the instrument air compressor. There are also a number of imported process parameters from this machine train not shown here (these include suction and discharge pressure and temperature, and motor current). In this case study, the bearing where high vibrations were detected is shown in red. Photo: Fretting on the first stage impeller bearing, presumably caused by a manufacturing defect.

Diagnostic assistance provided by the monitoring system supplier was able to determine that it was a bearing fault. The compressor manufacturer was also contacted, and after disassembly, they determined that fretting on the first stage bearing (Figure 1) was due to poor bonding of the bearing surface as a result of a manufacturing defect. This evaluation is based on the fact that the bearing vibration levels had already started an upward trend not long after commissioning. It is not fully understood why only the third order was excited for this condition.

The manufacturer replaced all the bearings under warranty and the intercooler drain lines were checked for proper draining of water to avoid carry-over. The inlet air filter was also thoroughly inspected for damage and openings.

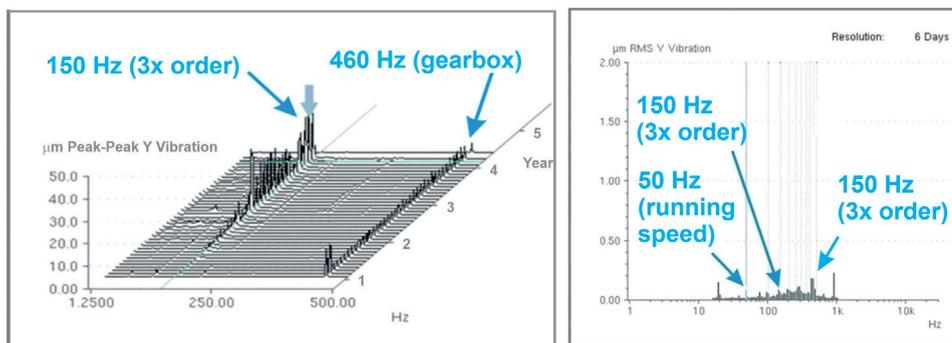
The bandpass vibration level on the inboard bearing of the first stage impeller had exceeded the alert alarm limits, so special attention was given to monitor its progression. As seen in Figure 2, the vibration trend had been increasing steadily for approximately one year. After a few months the vibration level subsided again, but after two years since the upward trend first started, the vibration level exceeded the alert alarm limits once again. It was then decided to shut down the machine to investigate the problem.

One of the first observations in the spectrum plot shown in Figure 2 was that the third order harmonic of the running speed from the inboard bearing of the first stage impeller started to increase more than two years before the shutdown. The bandpass vibration level increased for a while, stabilised and then decreased, and then increased again. This could be the result of a bearing fault that initially smoothed itself out for a while and then the fault redeveloped again. The DC vibration displacement (not shown) showed a more or less linear change in shaft position during more than three years. This indicates gradual wear of the bearing.

After repair, Figure 2 shows a spectrum plot (constant percentage bandwidth measurement of 6% centre frequency) where the third order harmonic for the most part disappears.

Figure 2. Left: The third order harmonic dominates the vibration response in this spectrum plot (FFT). The 460 Hz signal component from a gearbox pinion remains unchanged, thus precluding the possibility of a fault with this portion of the gearbox (higher frequencies not shown in this plot). Right: After repair, the third order harmonic disappears from the spectrum (constant percentage bandwidth – 6%).

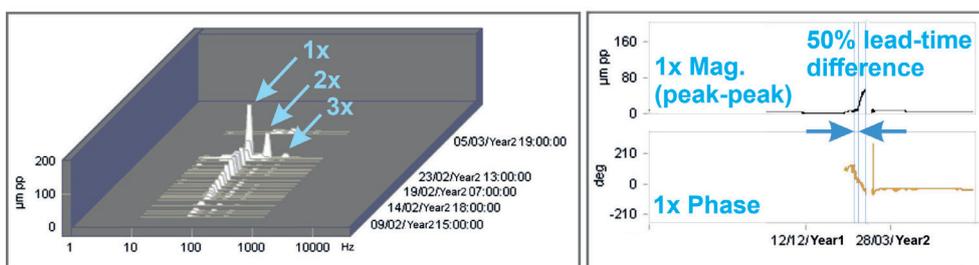
It was the running speed portion of the CPB measurement (Figure 4) that generated an alert alarm using the alarm trend function. The alarm trend was set up for a

10-day lead time to the danger alarm (shutdown). The CPB indicated a pronounced 1× vibration trend as shown on the left of Figure 4.

Although not set to alarm limits, the first order vector measurement data (1× magnitude and phase) was also analysed as a follow up. The 1× vibration magnitude portion of the vector measurement gave a similar lead time before shutdown to that of the CPB measurement, but the phase portion of the measurement started changing even earlier as shown in Figure 4. It would have given over two weeks advance warning.

When the gearbox was disassembled, the output shaft bull gear was found to be improperly mounted on its bearings. It was this fault that caused a running speed vibration amplitude increase and phase change. When the gearbox was repaired and reinstalled, the vector amplitude vibration went down and the phase stabilised.

Figure 4. Left: The CPB showing the running speed vibration increasing up until shutdown. The 2× and 3× orders of the running speed are also shown. Right: The first order phase is visible when the vibration amplitude is high enough, as shown in this long-term trend. Around 10 February the phase begins to change significantly. The first order vibration magnitude upward trend did not start until after 15 February.
