Case study – Outer race bearing creep detected on intermediate shaft of wind turbine gearbox

Application Note

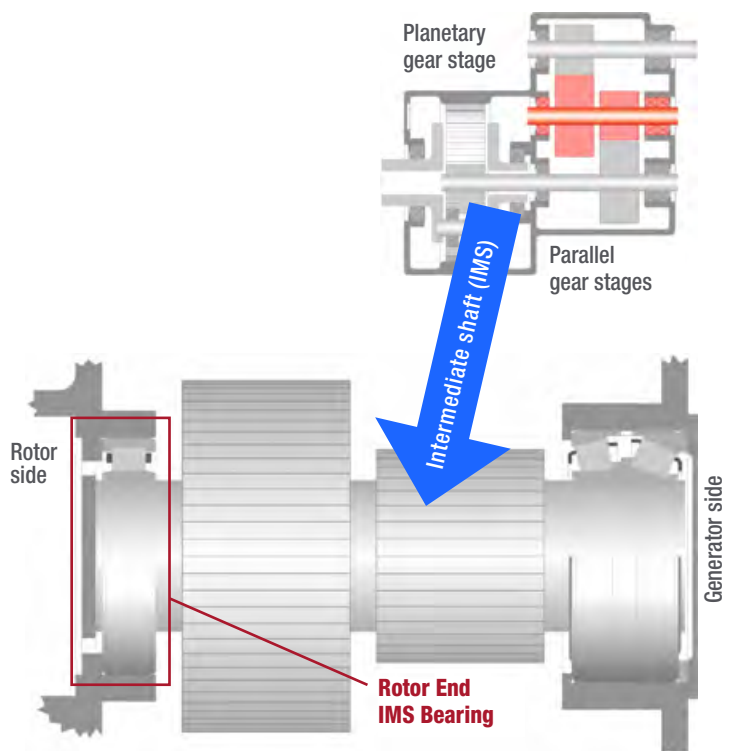
This application note deals with the rotor end bearing on the intermediate speed shaft (IMS), as shown in Figure 1, which is mounted between the bearing housing of the gearbox and the IMS. It is a single row roller bearing. The looseness detected in this case study is between the outer race of the bearing and the bearing housing of the gearbox.

Figure 1. The wind turbine gearbox (top) showing the intermediate shaft (IMS) highlighted in red, and a zoom of the IMS (bottom), showing the location of the rotor end bearing.

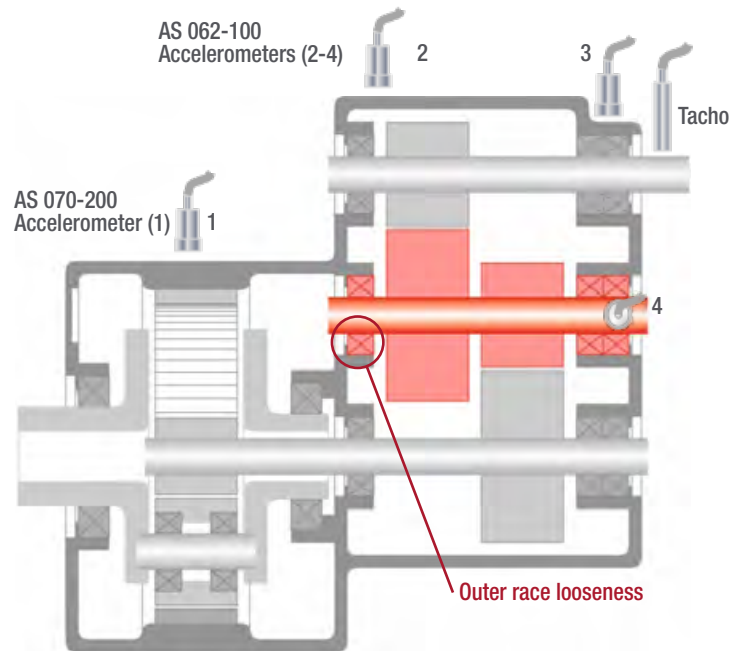
The sensor configuration shown in Figure 2 is typical for a three stage wind turbine gearbox. As can be seen in the figure, there is no sensor mounted close to the rotor end bearing on the IMS, so the signals used for the detection and diagnostics of the bearing looseness were taken from a combination of sensors, namely sensors 1, 2 and 4. This was considered satisfactory with regards to the vibration transmission path from the bearing to the sensors, which can vary a lot from one gearbox model to the next.

Figure 2. Sensor installation on the gearbox. Sensor 4 is shown mounted horizontally on the generator end (right side) of the IMS (shown in red).

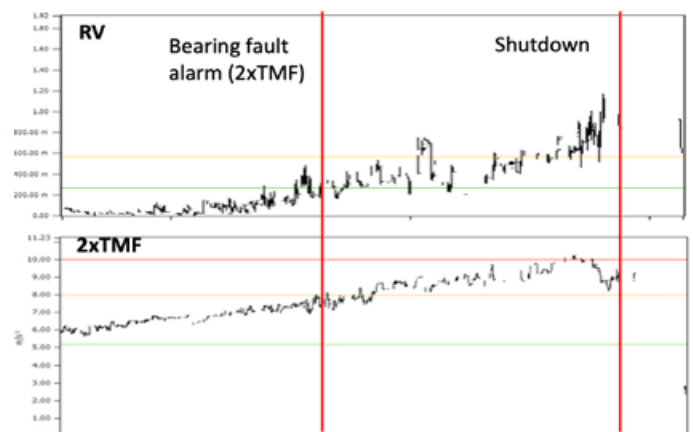
Figure 3 shows two detection measurements, indicating the date of detection, trend and shutdown for service. In this particular case there are two symptoms occurring at the initial stages of the fault development:

- **Gear shaft misalignment** – Seen by TMF harmonics
- **Modulation of TMF** – Due to load variations

Figure 3. Residual value plot (top) and 2xTMF plot (bottom).

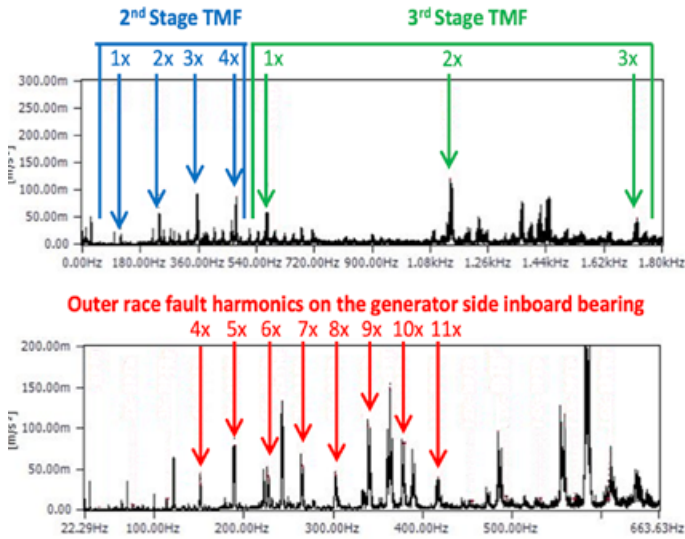
Figure 4 on the top shows the 2nd and 3rd harmonics of the TMF, greater than the first harmonic in amplitude, thus indicating gear misalignment. The bottom plot in Figure 4 shows bearing fault frequencies for the ball passing frequency (BPFO) of the generator end of the inboard bearing on the IMS. This is a strong indication that the rotor end bearing looseness (discussed later) has changed the shaft dynamics and increased the loading on the generator end bearing.

Figure 4. FFT plots for second and third stage gears (top) and generator side inboard bearing (bottom).

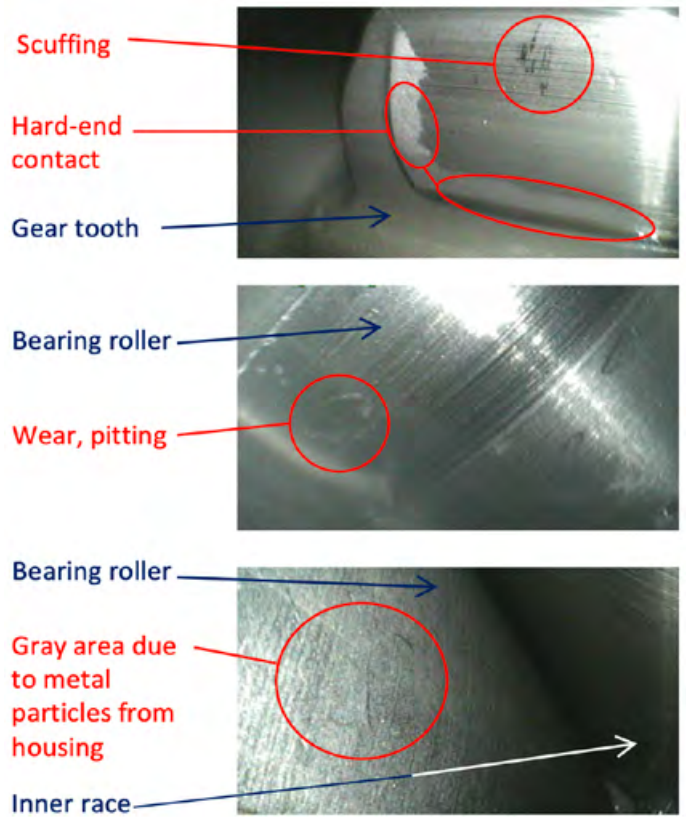
Figure 6. Endoscope camera pictures of the parallel gears and bearings: IMS gear (top), IMS-NRE bearing (middle), IMS rotor side bearing (bottom).

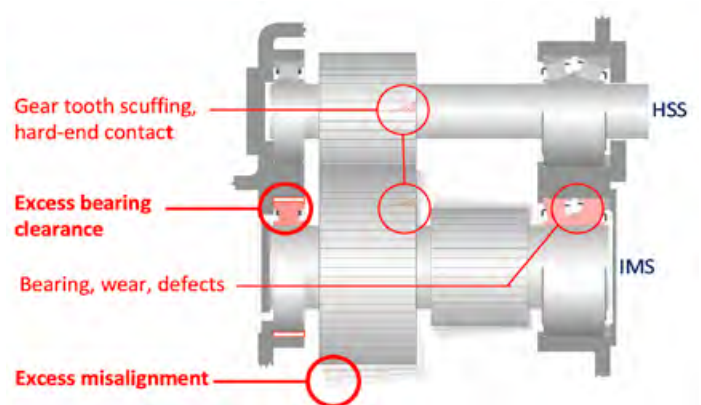
It has been determined that the outer race of the IMS rotor side bearing has been wearing the gearbox housing bore hole over time. This cannot be repaired up-tower and therefore will require a crane to remove the gearbox. The excess clearance of the bearing consequently results in excess misalignment of the shafts for the parallel stage gears. If the excessive clearance is not detected in time, misalignment of the parallel stage shafts causes tooth damage to the IMS gear and the high speed shaft (HSS) pinion plus damage to the IMS Generator side bearings. Even the mechanical oil pump operation can be affected

Figure 5. Results of excess clearance in the IMS rotor side bearing leads to damage of other components.

Without proper monitoring, replacement of only the damaged bearings and gears will not solve the problem and they will eventually be damaged again. Therefore the gearbox will have to be replaced to avoid this.
