## Diagnostic service with the VIBROPORT 8000 in a combined cycle plant

### Case Study

After many hours of successful operation, an overhaul and upgrade of the two 501F gas turbines at a combined cycle plant in the U.S. was planned. However, during the first gas turbine start-up, the protection system tripped, so a Brüel & Kjær Vibro (B&K Vibro) diagnostic specialist was called in to investigate. As no condition monitoring or diagnostics were performed at the plant, he brought the VIBROPORT 8000 with him for analysis. Looking at the data, he determined that there was a complete seal and/or blade tip rub. But what was the cause? He discovered that the upgrade did not match what was documented in the overhaul report.

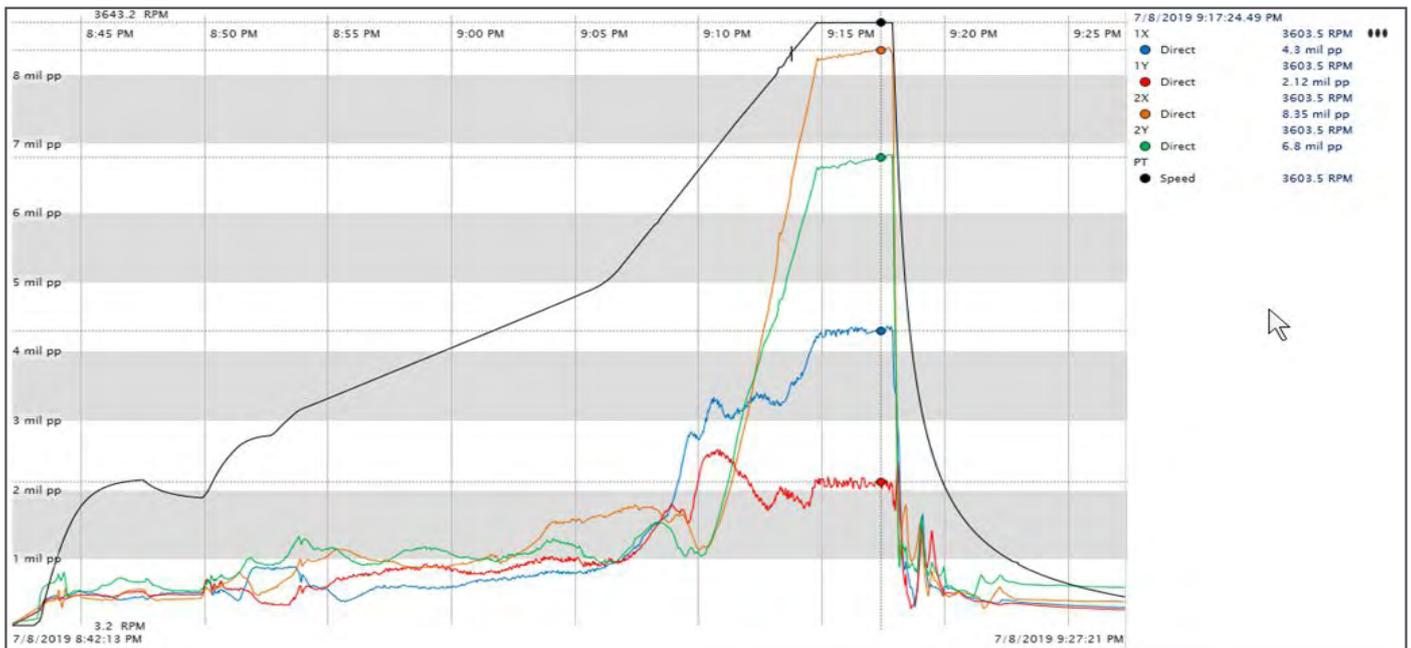
The VIBROPORT 8000 provided shaft centreline, orbit, and frequency spectrum plots during the second start-up (Figure 4).

- The orbit plot for the exhaust end of the gas turbine was flattened, while that for the inlet end was more open and with a larger amplitude. Both were forward precessed (see Figure 5).
- High amplitude second balance resonance, i.e., critical speed (not shown).
- Second resonance occurs at a higher frequency than normal for 501F units.
- Little change in slow roll conditions between cold start-up and warm coast-down.

- Little phase change with large amplitude increase at inlet.
- Very shortened coast down time ~14 min. versus 30 min. typical.
- Internal and coupling alignment and bearing loading appear acceptable.

- There is an indication from the plots that there was continuous contact hard rotor rubbing, i.e., a complete 360-degree rub. This could be the inner stage seal rubbing and possibly also blade tip rubbing.
- High rotor unbalance was evident, but it was not likely the result of rubbing-induced rotor bowing.

Figure 4. Initial post outage start-up for the gas turbine showing vibration trend during second start-up.

- Use a borescope to find evidence of blade and seal rubbing issues.
- Review all blade mass-moment weight and sequencing results.
- Verify installed blade sequencing matches calculations.
- Verify installed seal clearances.

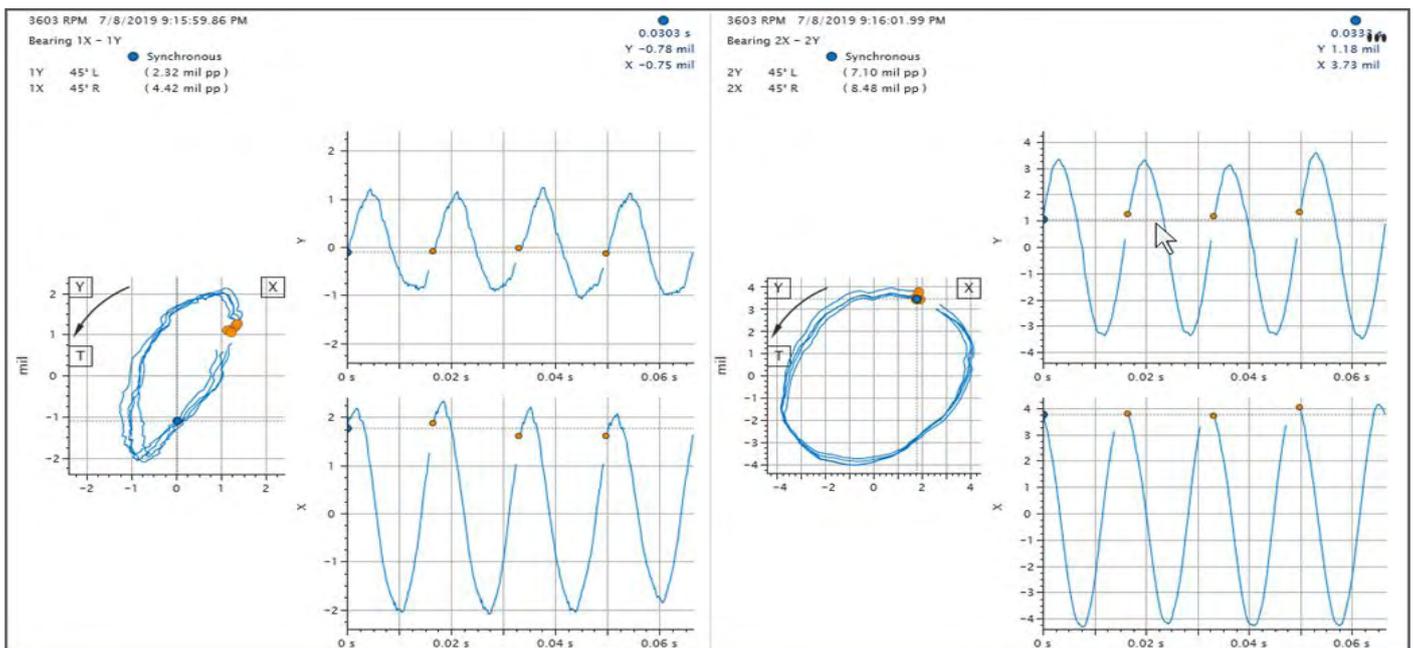
Figure 5. Orbit pots on the gas turbine inlet bearing (left) and the exhaust end bearing (right).
