Application Note

**Case study – Diagnosing
rolling-element bearing damage
in a hospital air-conditioner fan**

When a hospital machine maintenance customer requested a demonstration of the Brüel & Kjær Vibro portable vibration analysing instrument, it was used to carry out measurements and to analyse and diagnose a faulty rolling-element bearing in an air-feed fan of an air-conditioning system.

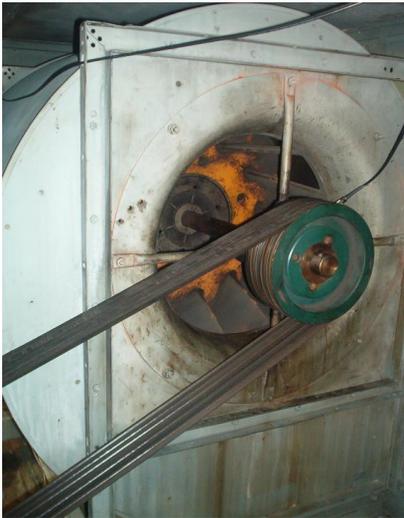
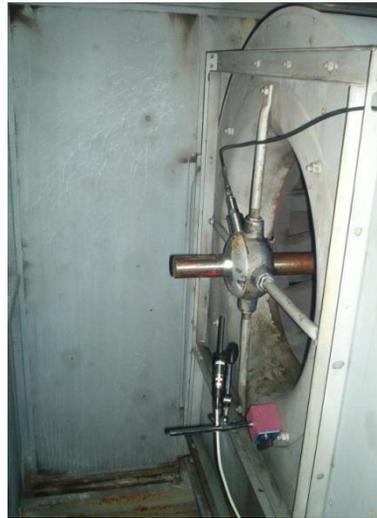
Figure 1. Drive-end (left) and non-drive end (right) of the air-conditioner fan showing the reference sensor setup.

After mounting the vibration sensors at the two bearings of the fan and setting up the reference sensor to provide a speed reference and phase signal, the Overall vibration and BCU values were measured and recorded as the first step in the vibration investigation. The table below shows the results of these
