# INTEGRATED VIBRATION & PROCESS MONITORING AT HPP MOMINA KLISURA

The COMPASS condition monitoring system was recently installed at the Momina Klisura hydropower station in Bulgaria as a part of a major refurbishment.

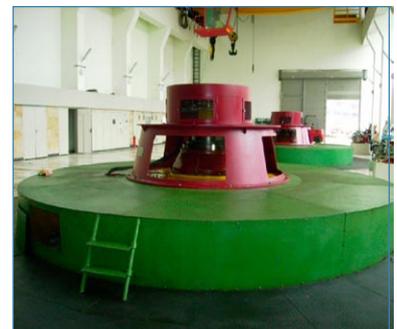
Figure 1. Momina Klisura 2x 60MW generating units.

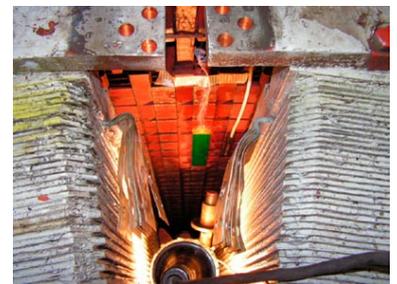
Figure 2. Mounting of the air gap sensor (green plate) and the magnetic flux sensor to the right of the air gap sensor between two poles on the stator laminates.

Machine	2x 60MW generating units with Francis turbines
Company/Process	NEK EAD, Bulgaria
Monitoring System	COMPASS condition monitoring system with radial & axial accelerometers, displacement sensors, tacho, air gap, magnetic flux, cavitation; data acquisition & conditioning units, a monitoring system server with a database and remote access
Monitoring strategy	Detection: first and second order magnitude and phase for shaft fault detection... Diagnosis: FFT & CPB spectrum, time signal, Bandpass, RPM, DC, Smax, high frequency emissions
