Success Story

NACELLE MONITORING COMPLIMENTS DRIVETRAIN MONITORING

Nacelle monitoring in a wind turbine, using accelerometers mounted on the nacelle frame, is an essential part of a holistic condition monitoring approach for wind turbines.

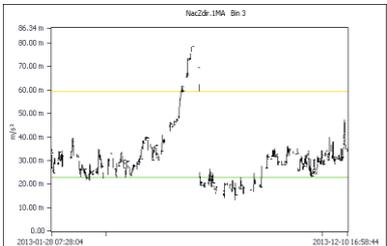
Figure 1. Vibration trend at rotor speed in the downwind direction under increasing pitch misalignment.

Blade misalignment – When there is a difference in pitch between the three blades, this changes the rotor aerodynamic loading and consequently results in running speed and blade passing frequency vibration in the downwind direction (see Figure 1).
