# Application Note

## VIBROCONTROL 6000™ at Huntly Power Station

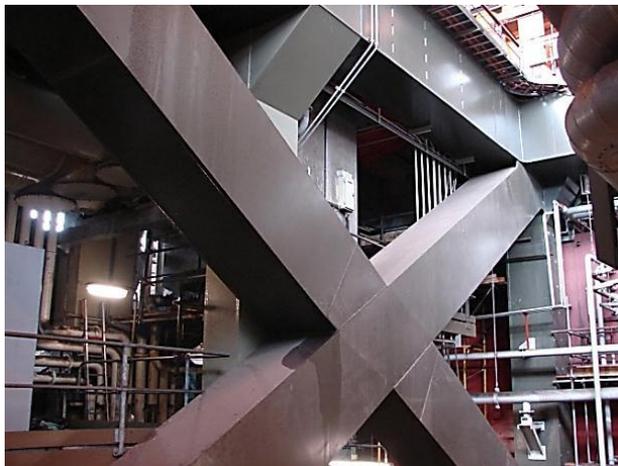
Figure 3 Steel Foundation Structure

The Huntly machines are unique in that the foundations are designed with earthquake isolation in mind and are all steel.

The flexible nature of these foundations meant that the generator inboard bearing had a resonance at running speed and the generator 2nd critical was just below the running speed which makes these machines extremely sensitive to couple imbalance.

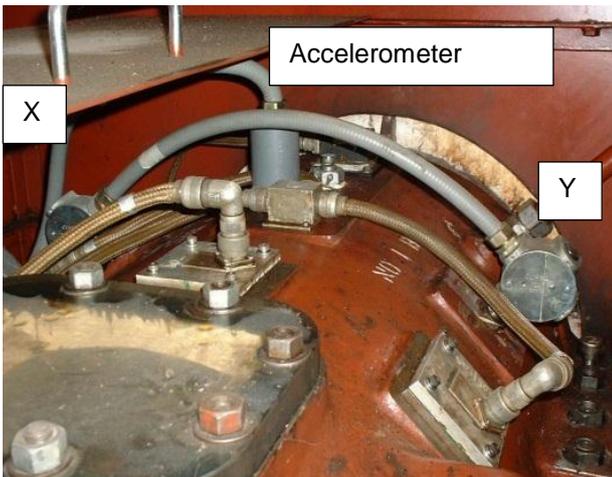
Figure 6 Bearing showing the X/Y transducers

On the main machine the Compass system monitors relative shaft position and motion on each of the 8 main bearings, the eccentricity of the 3 turbine shafts, the differential

expansion of the 3 turbine shafts, the axial position of the shaft relative to the thrust bearing, and the pedestal vibration of each of the machine's 12 bearings. In addition, the Compass system monitors the casing expansion on both sides to check for crabbing or sticking of the sliding feet.

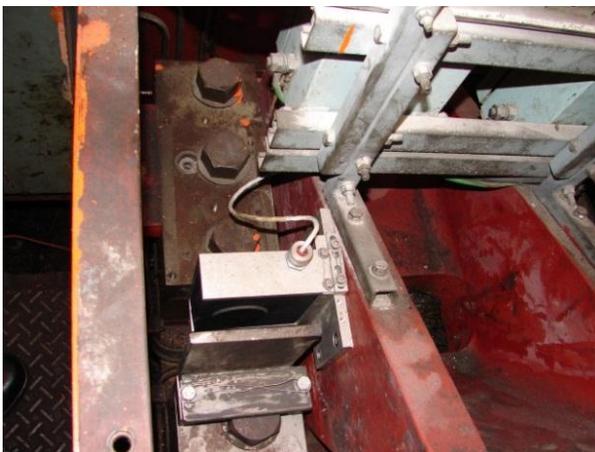
Figure 7 Casing expansion transducers

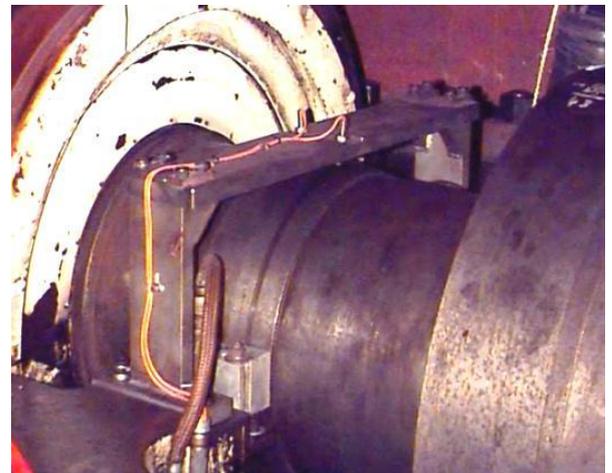
Figure 9 IP Differential expansion transducers

The differential expansion is measured using two proximity probes looking at a 6° tapered collar machined on the shaft.

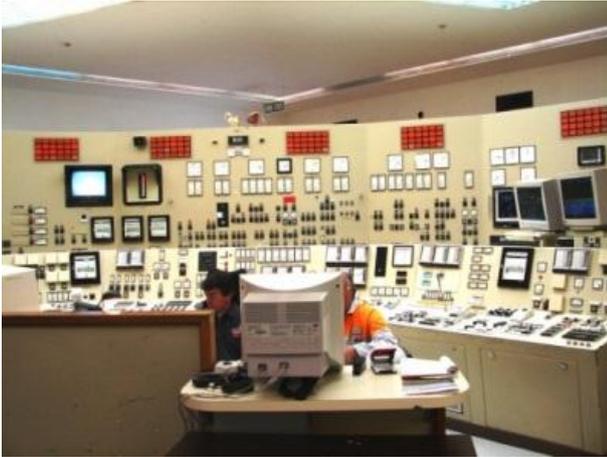
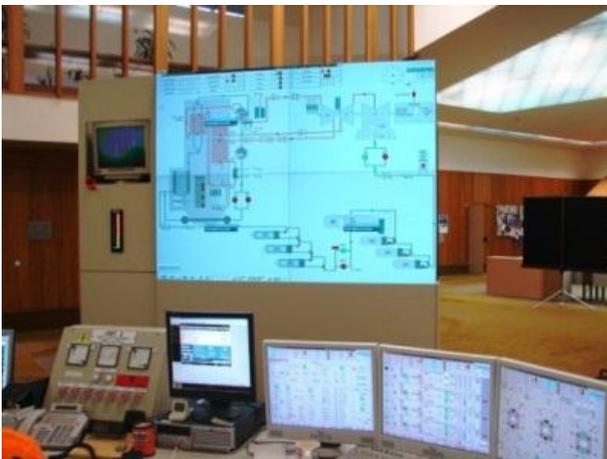
Figure 10 Analogue control and DCS for one Unit

Over the last few years Huntly has upgraded the control system from analogue to a DCS and during this process the Compass system was integrated into the controls and various Compass alarms either hold the run up or the loading, and at higher levels trip the machine.

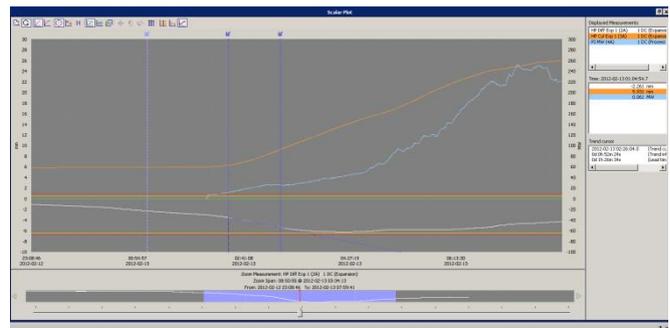
The key to controlling the differential expansion is to match the steam to metal temperatures and by holding the load to allow the turbine to “heat soak”. As can be seen in the Compass VC-6000™ plot below, the load (blue trace) is held for a period of time which allows the HP differential (white trace) to stabilize.

Figure 11 Trend of the differential expansion

One of the critical measurements on a steam turbine is its differential expansion. This is a measurement of the relative expansion between the turbine shaft and the turbine casing. The design of the turbine is such that the thermal inertia of each component is as close as possible. Matching these expansions is quite hard as the shaft is totally surrounded by steam whereas the casing only has steam on the inside. A turbine will typically experience differential expansion problems on start up. If the start-up is from cold, then the shaft will expand faster than the cylinder, in the direction towards the rear of the turbine. By the machine manufacturer's convention this is referred to as a negative differential. If the start-up is from hot then it is possible for the shaft to contract and the differential will go in the positive direction, i.e. towards the front of the turbine. This measurement is critical because of the small clearances between

the front of the turbine blades and the stationary cylinder components. This clearance is kept as small as possible to reduce steam leakage around the blades (i.e. to reduce efficiency losses), whereas the clearance on the back of the blades is much larger because of the lesser sensitivity to efficiency losses. The positive differential limits are therefore quite small and on the Huntly HP turbine the alert limits are 0.5mm +ve and 6.35mm -ve.

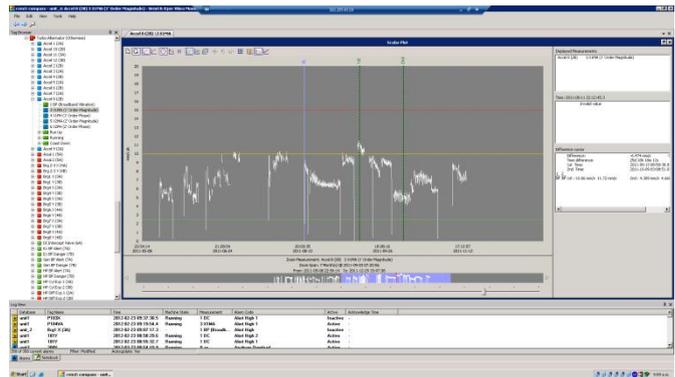
Figure 12 Trend of the bearing vibration

In 2010 we noticed that the 1x vibration on the generator outboard bearing had some variation from one run up to the next. These units are very sensitive to a small degree of balance change and a few years ago we noticed a similar behavior on unit 4 but on the inboard bearing. At that time we arranged to remove the generator end-cap as we suspected that the end winding blocks were loose and were shifting causing a balance shift. On removal of the end cap this proved to be the case and the blocks had been shifting causing some insulation damage and small balance changes from run to run.

In this case our immediate action was to limit, as far as possible, the number of stops and starts as we again suspected shifting end blocks. By the end of 2011 the variation was up to 6 mm/s.

What was found when the end caps were removed and the excitation leads were disconnected from the windings was that the exciter leads had work hardened and fatigued to the extent that they were no longer fully connected and had arcing damage inside the insulation. This was, in fact, the cause of the balance variation we had seen in service.
