**Case study – High technology  
in monitoring and detection of  
rolling-element bearings at low  
rotational speeds of 3.5 RPM**

# Case study – High technology in monitoring and detection of rolling-element bearings at low rotational speeds of 3.5 RPM

### Case story 1 - diagnosis description of a defect in the outer ring of the rolling-element Timken bearing 93825 at low rotational speed, only 3 rpm

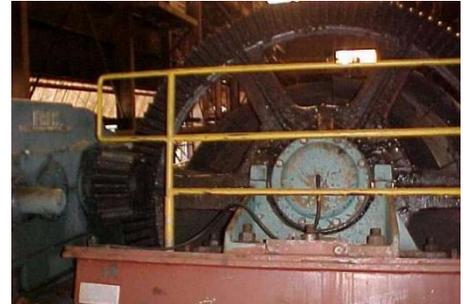
Figure 2. Classifier.

One of the monitored machines that was diagnosed is the classifier 6301, located in the treatment plant at the Conceição Mine. Its function in the system is quite important, since it classifies a product called hematite. If the classifier is stopped for repairs, this will stop 50% of the hematite production line, which is 1250 tonnes of iron ore per hour.

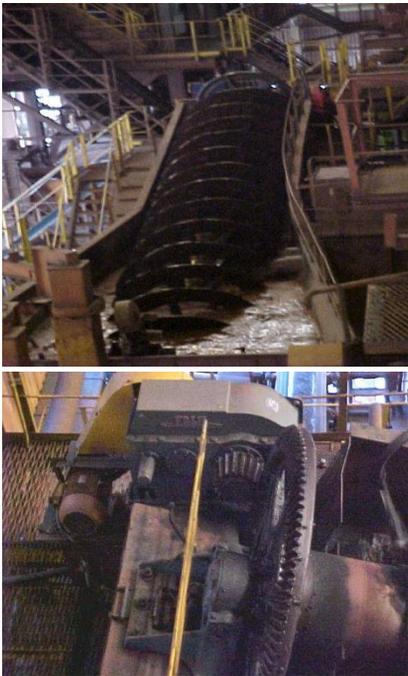
Figure 3. Drive train of the classifier.

This machine is composed of an electric motor that turns at 1200 rpm (20 Hz) and is stepped down in speed through pulley wheels to 585 rpm (9.75 Hz). The input shaft of the gearbox turns the middle shaft at 96 rpm (1.6 Hz), which in return turns the output shaft of 17.4 rpm (0.29 Hz). The tooth meshing frequencies in the gearbox are 126.7 Hz at the input and 27.2 Hz at the output. On the output shaft there is a pinion gear that turns a crown that is coupled to the classifier's spiral shaft. Afterwards the gearbox (which has an input of 17.4 rpm) is stepped down to 3.48 rpm (0.058 Hz), the

rolling-element bearing on the spiral shaft is the Timken 93825, as seen in Figure 3.

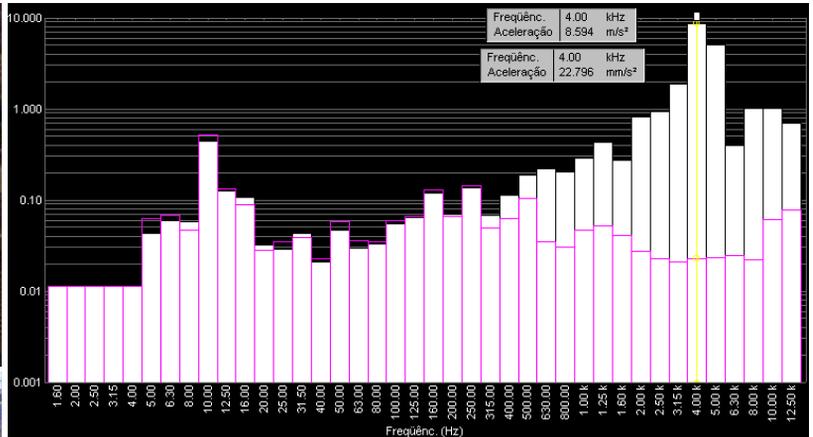
Figure 4. CPB23% of the spiral shaft bearing of the classifier.

With the use of this technique it was possible to accommodate all frequencies in the range from 1.6 to 12.5 Hz; making it simple to find out which frequency is developing and what is its origin. Below are some frequencies that indicate increasing amplitudes and cause alarms:

- 10 Hz frequency corresponds to a 2x external toothmeshing frequency with an abnormal symptom in the toothmeshing caused by irregular contact of the teeth - as an ellipse.

- 4k Hz occurs in the region of structural resonance, which is excited by repetitive, periodic impacts, excited by the impacts originating from the contact of the rolling element with the defective external race.
- Before repair the amplitude of the 4k Hz frequency (region of excited structural resonance) was 8.5 m/s<sup>2</sup>, and after replacing the bearing was down to 22 mm/s<sup>2</sup> as shown by the pink bar in the CPB in Figure 4.

- It is confirmed that the natural frequency of the bearing is independent of its rotation, but is dependent on the bearing assembly mass, spring and damping (rigidity) properties. The waves of impact between the rolling element and its external race creates harmonics, one of which coincides with the natural frequency of the bearing (high frequency). Therefore it is the amplitude (signal intensity) that is altered, which depends on the velocity of the element impact (kinetic energy impact), and this velocity depends on the rotational speed. These frequencies, which are the result of the impacts, are low frequency (which modulate at high frequency) and do not have enough energy to vibrate the bearing.

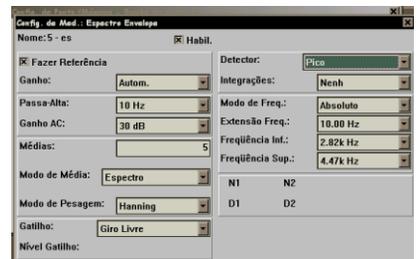
Figure 5. Envelope setup. Frequency 0.88 Hz. Toothmeshing frequency 5.5 Hz with pinion gear modulation of 0.22 Hz and smaller frequency amplitude bands of rotation of the crown gear of 0.058 Hz.

Envelope setup configuration in Figure 5 shows the flexibility in making an envelope in 1/3 octave bands while selecting upper and lower limits of the frequency range taken from the CPB23%. One of the advantages of the SED (selective envelope detection) is that it allows the elimination of random noise (carpet noise) that could amplify some frequencies and attenuate others, making it possible to make an amplitude trend without outside contributing factors (amplifiers). The SED offers another advantage for trending a rolling element defect by the magnitude modulation method, which is the relation between the level of the major harmonic component of the defect in the spectrum and the level of the carpet noise.

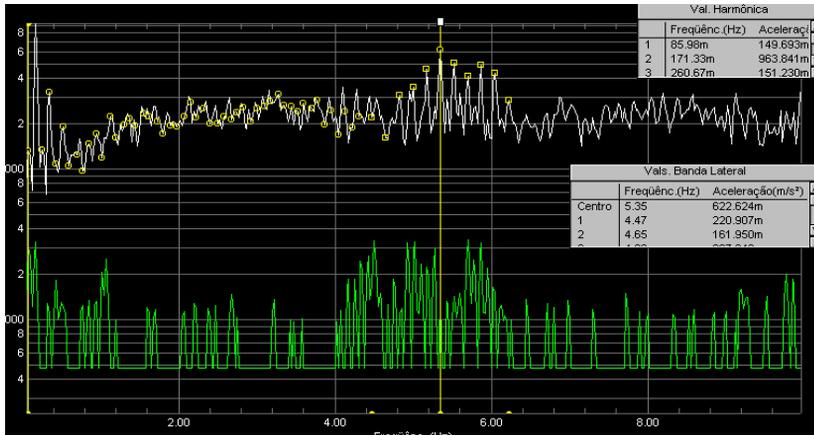
Figure 6. Envelope plot.

impacts of the rolling element, we make an envelope with a narrow filter that permits the resonance region to show itself at 10 dB. We demodulate at low frequency in a spectrum with a span of 10 hz at a resolution of 0.025 Hz.

While analyzing the envelope spectrum in Figure 6, we have proven the success of a group of factors that make up the procedure for diagnosing rolling element bearings that turn at low speed (3.5 rpm), in respect to the steps mentioned above. In this spectrum we verify the external race harmonics, especially the second harmonic of 0.88 Hz. After replacement (shown in green) the levels diminish to normal, including the external toothmeshing frequency that was excited by rotational frequency modulations of the pinion gear.
