Application Note

Case study – Machine condition monitoring strategy at the Żarnowiec pumped storage power station

ABSTRACT

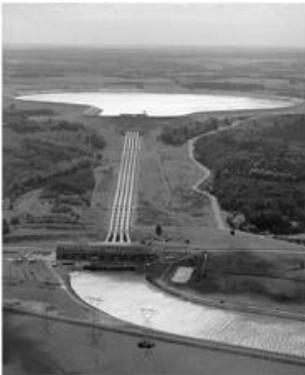
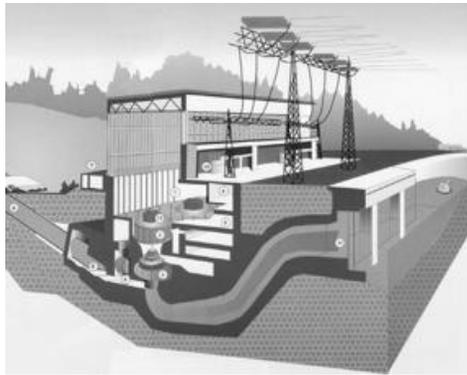
Figure 1. Żarnowiec pump storage hydroelectric power station. The 10.5 m diameter generators produce 179 MW from a 180 m³/s flow at 166.7 rpm.

The 716 MW Żarnowiec pumped-storage hydroelectric power station shown in Figure 1 is located between an upper artificial reservoir and the glacial lake Żarnowiec in Northwestern Poland. Owned by Elektrownie Szczytowo Pompowe SA (Pumped Storage Power Plants SA) and operated by Elektrownia Wodna Żarnowiec SA (Żarnowiec Hydropower Plant SA), it is the largest hydroelectric power station in Poland. Żarnowiec power plant - one of five pumped storage

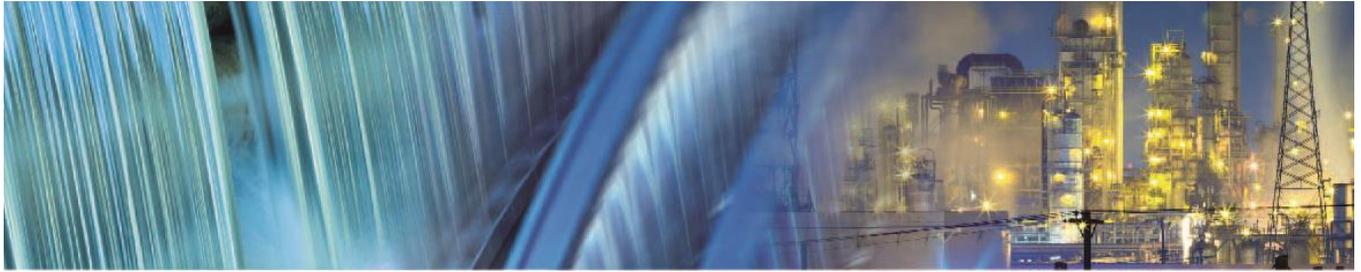
Figure 2. Monitoring strategy for each of the four units.

A permanently installed monitoring system (on-line) is used to monitor the stator, generator and turbine guide bearings, thrust bearings and the turbine inlet and draft tube as shown in Figure 2.

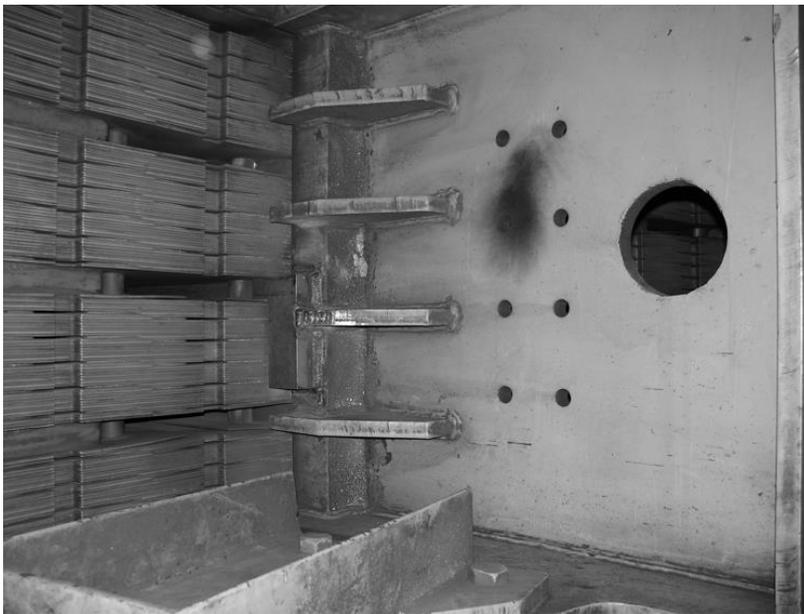
Figure 6. Modified rotor rim support structure.

a single web support contact point for the entire stack of rotor rim plates for each support. This was considered insufficient so it was decided to make a modification with three support webs for each support as shown in Figure 6. This was eventually done for all the units.

It was determined the support prematurely broke due to fatigue. The original design was based on
