# APPLICATION NOTE

## Excessive vibrations on 250-MW turbo-generator bearings due to flexible steel foundations

*Excessive bearing vibration was detected during commissioning of a 250 MW turbo-generator at the Huntly Power Station. Further investigation determined that it was resonance caused by the flexible steel foundations used for earthquake protection. The optimal solution was a dynamic vibration absorber that was mounted directly on the bearing pedestal. Although this solution prevented the bearings from being damaged prematurely, vibrations are still relatively high during run up.*

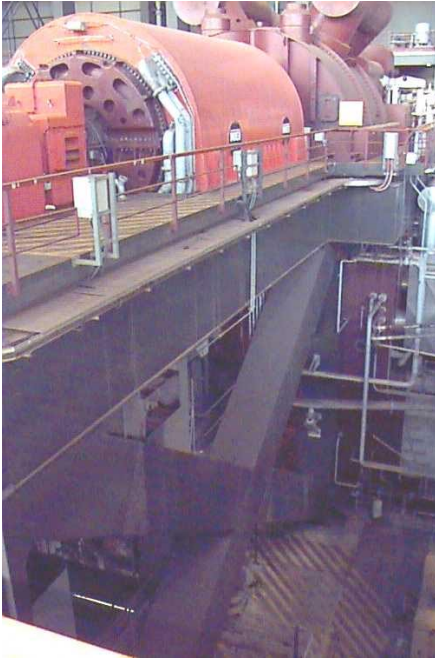
Fig. 2 Flexible steel-beam foundation for earthquake protection

foundation structure. These measurements indicated that the resonance was due to lack of horizontal stiffness of the bearing pedestal and the foundation hollow steel beam to which it was mounted (Fig. 2).

very high horizontal vibration (18 mm/s Peak) that peaked at the machine running speed (3000 RPM). Further investigation indicated that the high vibrations detected at bearing 7 were due to a horizontal resonance at 100 Hz (twice machine speed) in the flexible cross beam to which the bearing pedestal is mounted. This resonance was being excited by the generator gravity critical (a function of the differential stiffness inherent in the construction of two pole generators). Even though the installed transducers monitor vibrations only in the vertical axis at that time, the horizontal resonance rocked the bearing housing in such a way that a portion of it was seen in the vertical axis.

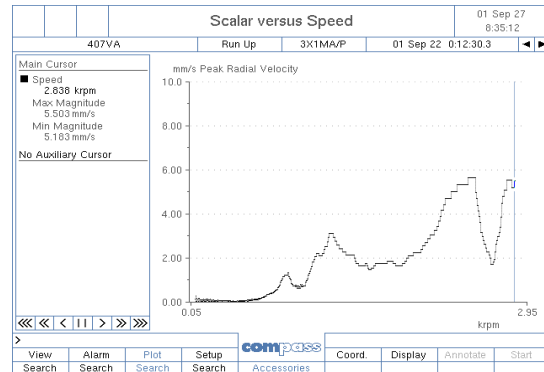
Fig. 5 Generator shaft 1× vertical-axis vibration during run up (second critical speed)

Even with a reduced 100 Hz horizontal resonance and a reasonably good state of balance, the overall vibration still is high at 24 mm/s at 2750 RPM during run up, as seen in Fig. 7. This is because the overall vibration is the vector sum of the horizontal resonance (Fig. 6) plus the 1x running speed vibration that results from being so close to the second critical speed of 2800 RPM, which cannot be reduced (see Table 1 and Fig. 5). The overall vibrations during run up at machines speeds from 2750 to 2850 RPM can be significantly higher if there is imbalance present.

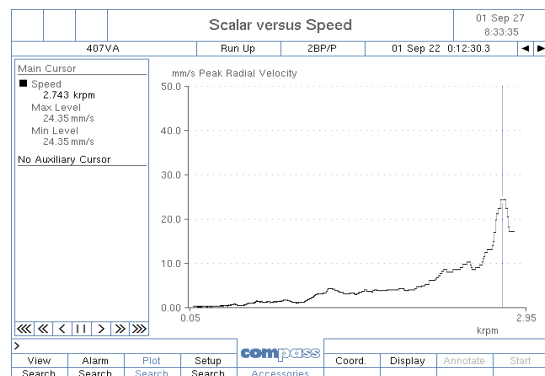
Fig. 7 Generator shaft band-pass vertical-axis vibration, 10 Hz-1kHz, during run up (vector sum of 1× and 2× running speed frequency components)

As was previously mentioned the vibration absorber splits the 100 Hz horizontal resonance such that a lower frequency resonance of 91.5 Hz is introduced at a machine speed of 2750 RPM. When all four weights of the absorber have been optimally tuned
