uptime  
magazine

1 • 11  
Hydro: Magnetic flux • A06 module • Field news • Case study / Turbo-machinery diagnostics

Magnetic Flux Monitoring of Hydro Generators

# Early detection of a compressor impeller crack

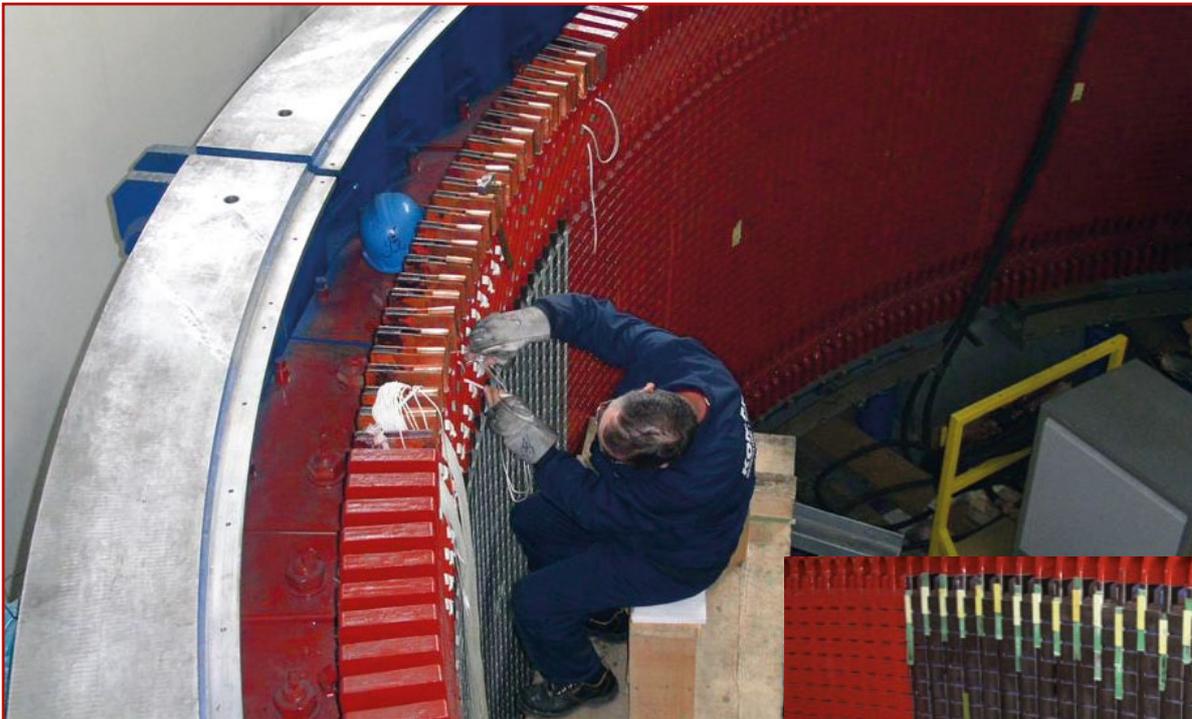
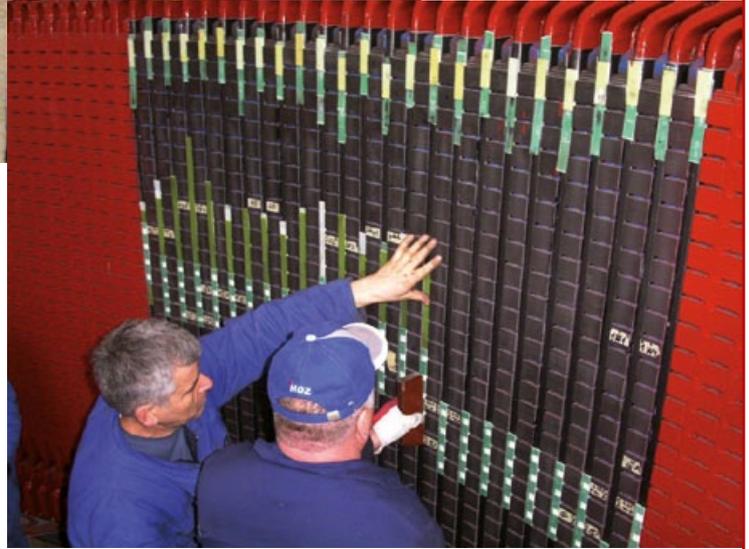
*Figure 2. Magnetic flux sensor shown on the left, air gap sensor shown on the right.*

The magnetic flux sensor system (e.g. Brüel & Kjær Vibro EQ 2430) includes a long thin sensor that is permanently glued to the inner wall of the stator. It is attached to a signal conditioning box/ power source a few meters away by signal wires that pass through the stator ventilation

The magnetic flux sensor resembles an air gap sensor (e.g. Brüel & Kjær Vibro EQ 2431) and in fact both are installed in the same way, but this is

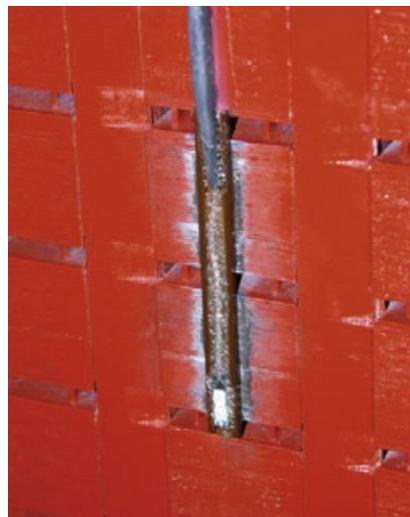
*Figure 1. Preparation of a hydro generating unit stator (prior to installing the magnetic flux sensor).*

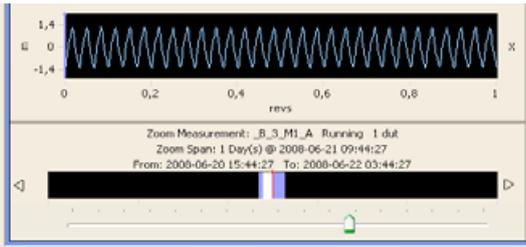
Figure 3. Compass 6000 plot above showing the raw time signal that is saved in the database for diagnostic purposes.

The raw time signal for one rotation of the rotor shows the magnetic flux for each pole, as seen in Figure 3. This signal provides valuable diagnostic information, but it is not monitored to alarm limits. For this purpose the signal is conditioned as shown in Figure 4. A single maximum peak value for each pole is extracted and is monitored to alarm limits and trended over time as shown in Figure 7. These values, corresponding to a specific pole, can be correlated to the values from other poles, or correlated to process conditions such as winding temperature, exciter current and voltage, and air gap measurements. The

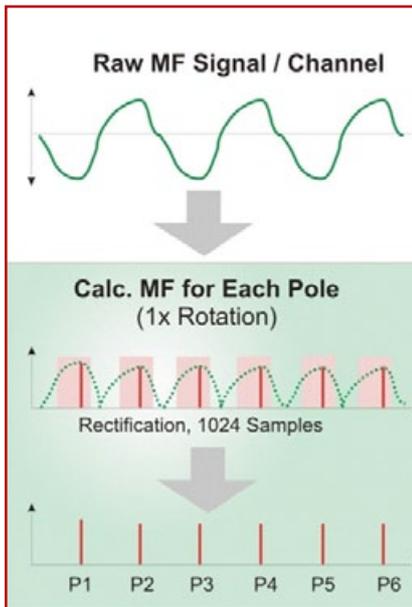
Figure 4. Maximum peak value extracted for each pole (single value) to be used for monitoring, trending and alarming purposes.

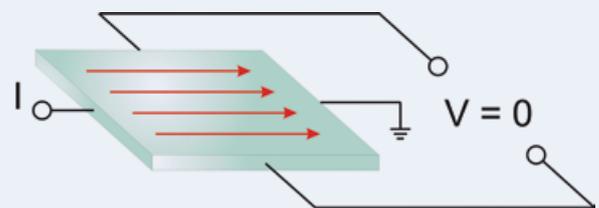
Figure 5. No magnetic field present.

A Hall effect element similar to that shown in the figures below is built into the magnetic flux sensor. Assuming the sensor current is constant, the output sensor voltage of the sensor, i.e. the Hall effect voltage  $V_H$ , will be directly proportional to the strength of the magnetic field of each passing rotor pole.

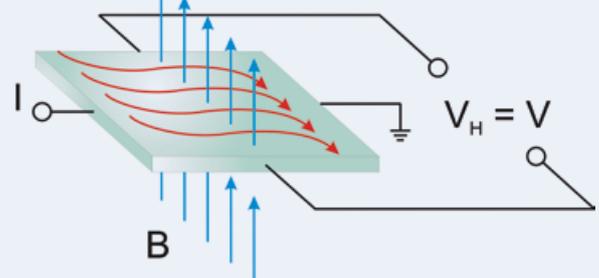
Figure 6. Hall effect principle, magnetic field present.

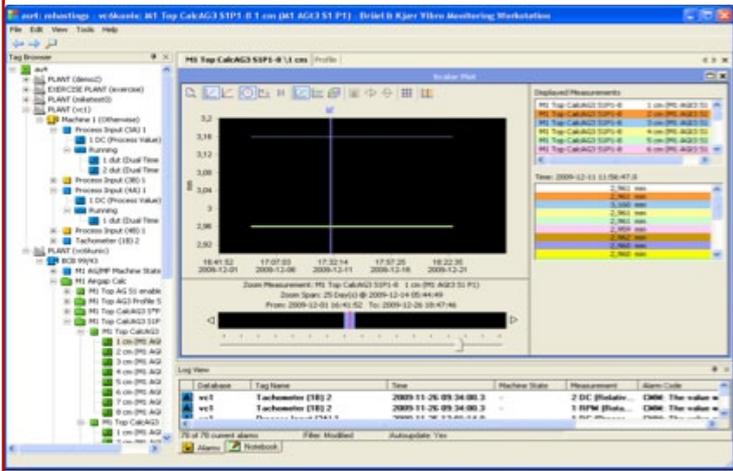
Figure 7. Compass 6000 multi-trend plot showing the maximum peaks for each pole, trended over time. These values are monitored to alarm limits.

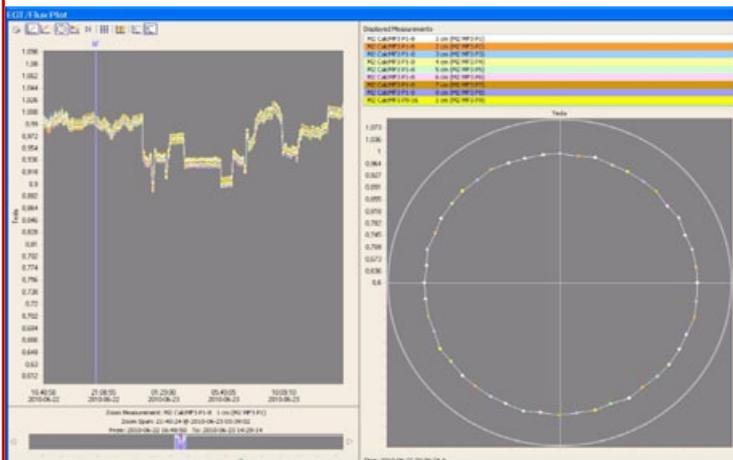
Figure 8. Compass 6000 plot showing the magnetic flux maximum peak value for each pole for one rotation in a circular plot.

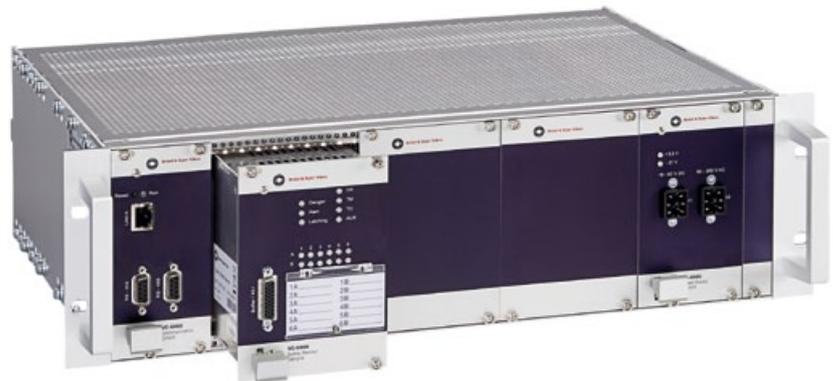
### Features:

- **Inputs** Up to 11x vibration, up to 2x axial position, 3x binary inputs and up to 2x speed inputs (for machine state definition) and a 1x master trigger input signal (for other modules)
- **Outputs** – Up to 8x DC outputs and 2x relays (with user-defined voting logic)

- **Machine states** – 6 user-defined machines states (up to 8 for safety monitoring applications)
- **Hot swappable module**

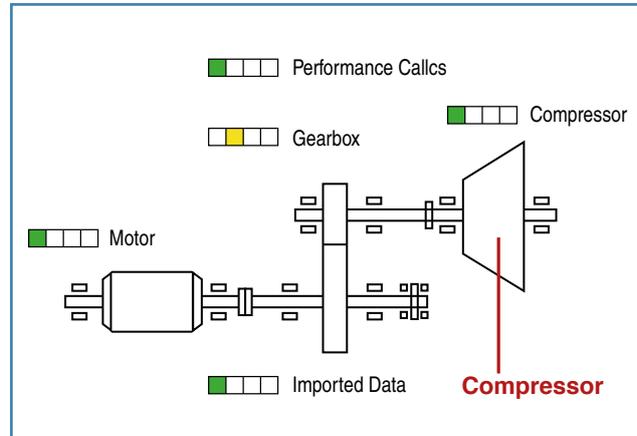
Figure 1. Compressor train (top) and in-board and out-board vibration measurement points (bottom).

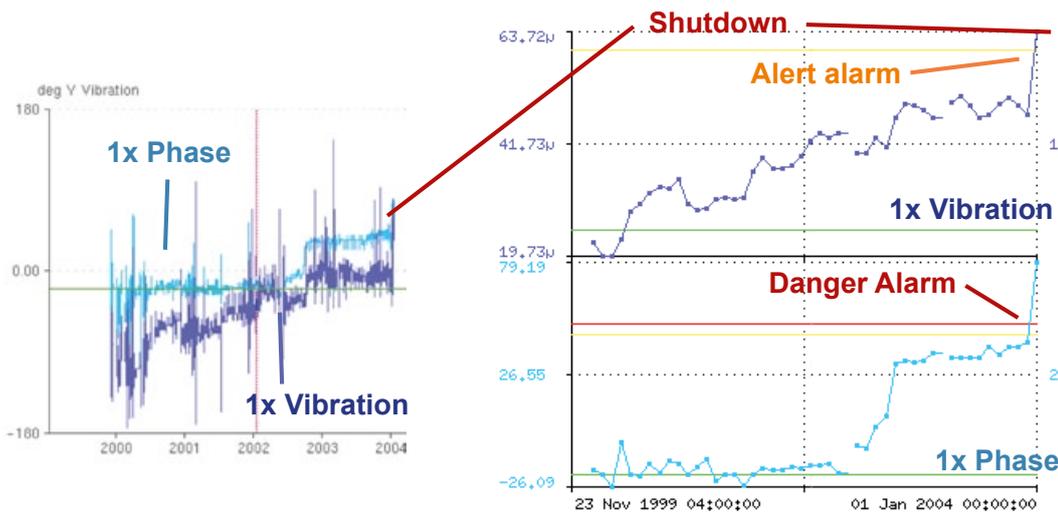
Figure 2. Vector radial vibrations on the inboard bearing: Alert alarm limits exceeded by 1x vector magnitude vibration at running speed. Danger alarm exceeded by 1x vector phase.

Looking back at the data in Figure 2, the changing 1X vibration and phase is an indication of a shaft/rotor crack<sup>1</sup>. It is interesting to note that the vibration was higher at the inboard bearing position (stage 4) than the outboard (stage 1) position where the impeller crack appeared (see Figures 1 and 2). The compressor manufacturer confirmed this to be consistent for this type of machine. The effects of the mass balance between the first and fourth stage can influence the location where the first stage 1X vibration will be evident.

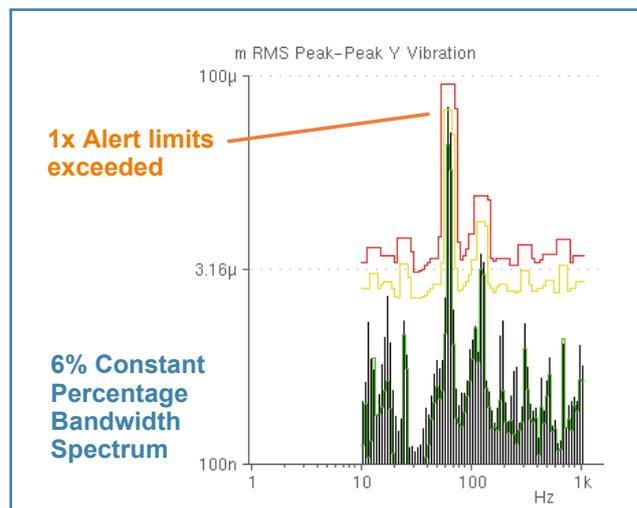
Figure 3. Spectrum radial vibrations on the inboard bearing: Alert alarm limits exceeded by 6% constant percentage bandwidth spectrum (CPB6%) at running speed.

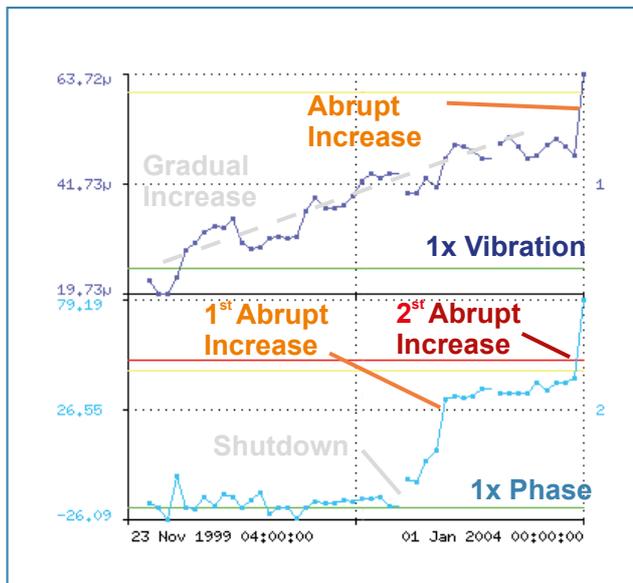
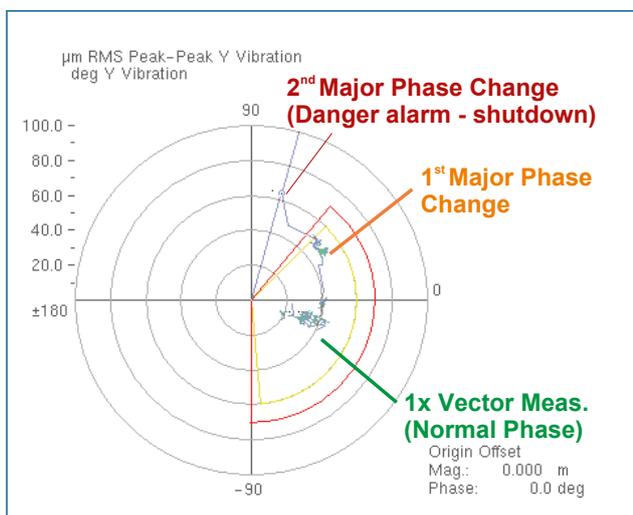
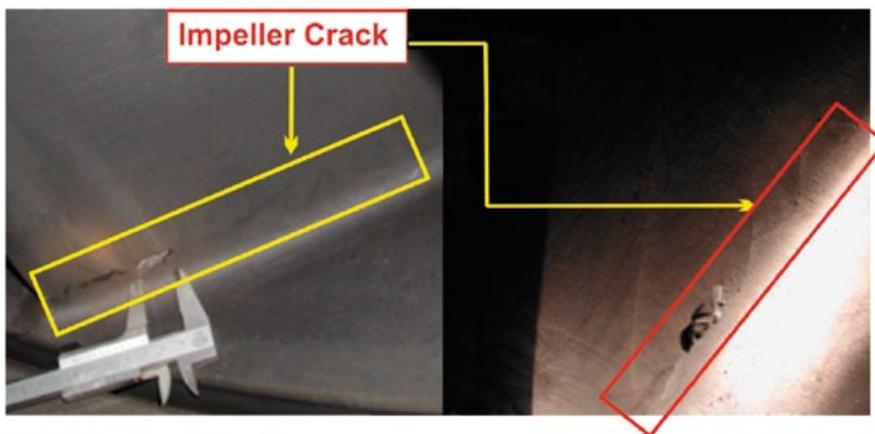
Figure 4. 1x vibration magnitude increased gradually from 2001 to 2004, where there was an abrupt increase in January 2004. 1x vector phase increased abruptly first after the shutdown in June 2002, and then again in January 2004.

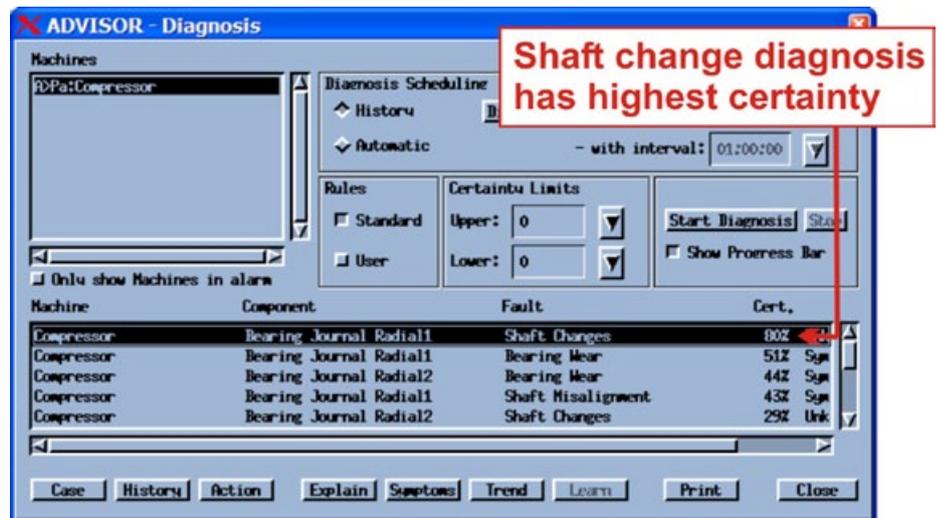
Figure 5. ADVISOR lists all likely and unlikely diagnoses for a given database scan. The diagnosis with the highest certainty after 21 November 2002 is the “shaft change” (i.e. a rotor dynamic change, such as a change in stiffness, which can result when there is a rotor crack). Other machine faults can be seen listed below this one.

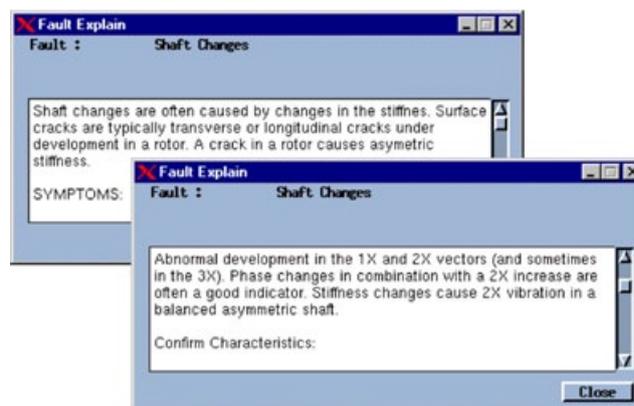
Figure 6. ADVISOR description explaining the rules and symptoms used in the diagnosis.

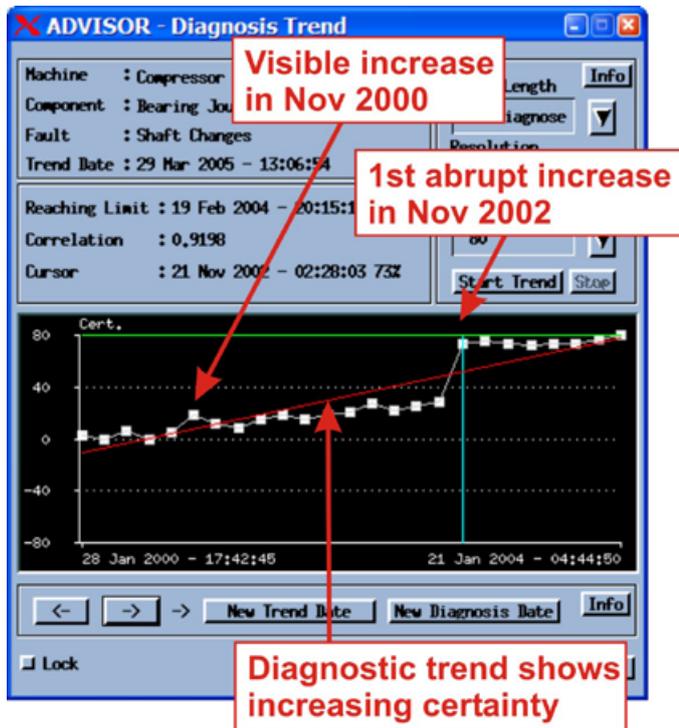
Figure 7. This plot shows the calculated certainty of the shaft crack diagnosis by ADVISOR. Already by 21 November 2002 the certainty of diagnosis was up to 80% (the highest certainty level of the system). Even though the certainty levels of the rotor crack diagnosis are relatively low prior to this date, the diagnostic trend has been increasing in terms of probability (certainty) the entire time.

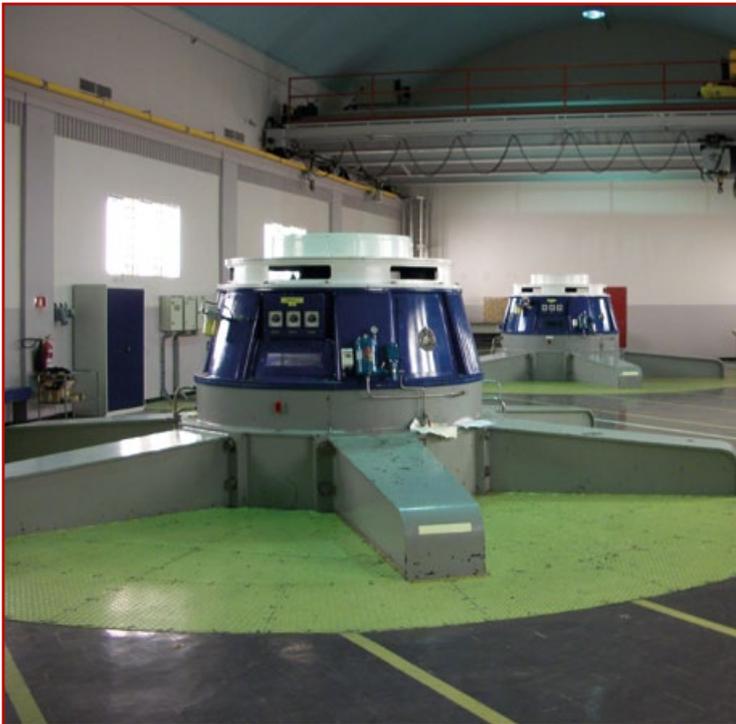
Figure 2. Aunfoss generator hall.

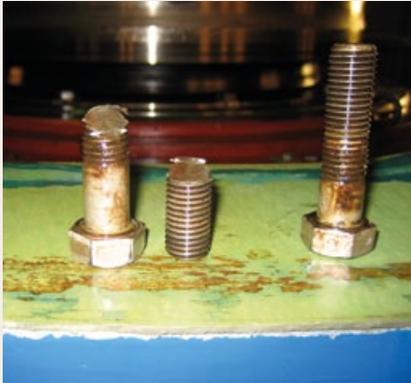
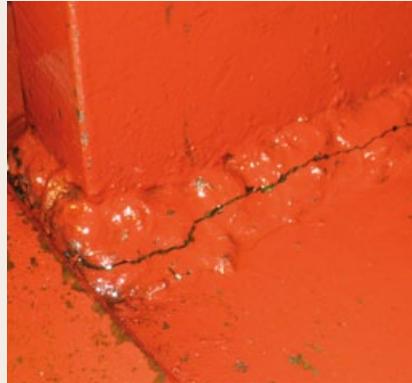
Figure 4. Generator bearing bolt damage (left). Damage to the generator bearing housing weld (right).

for implementing vibration monitoring. At Aunfoss, as shown in Figure 4, the generator bearing bolts failed as a result of excessively high vibrations. A similar vibration related failure is evident in the weld of the generator bearing housing shown in the same figure. Both of these faults could have easily

been avoided, with the problem detected with sufficient lead time for service action, by the operation of a vibration monitoring system.

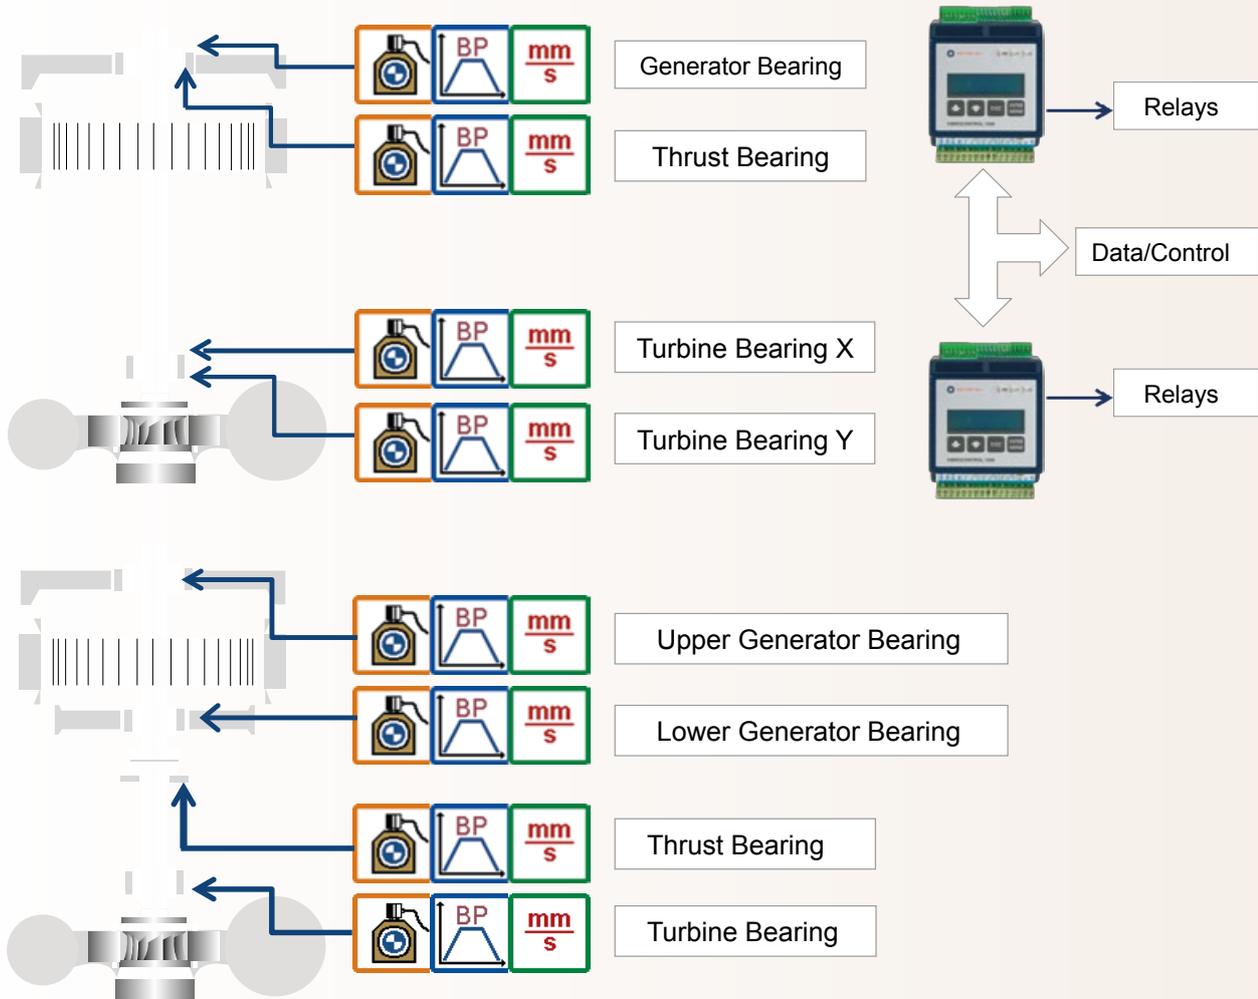
Figure 5. Top, the monitoring system configuration at Aunfoss. Bottom, a typical installation configuration for a 3-bearing hydro generating unit construction, of which NTE has several (this is shown for illustrative purposes).

Two VC-1500 monitors are used for each turbine at Aunfoss (see Figure 5 on the next page). One monitor is used for the turbine guide bearing, which is equipped with two radial X-Y accelerometers installed 90 degrees

apart. The second unit is used to monitor the generator bearing, with one accelerometer in a radial direction and the other for the thrust bearing in an axial direction. The accelerometer installation is shown in Fig. 6.

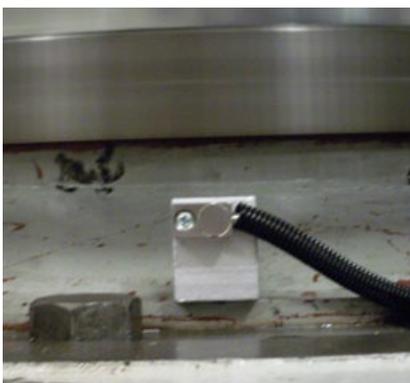
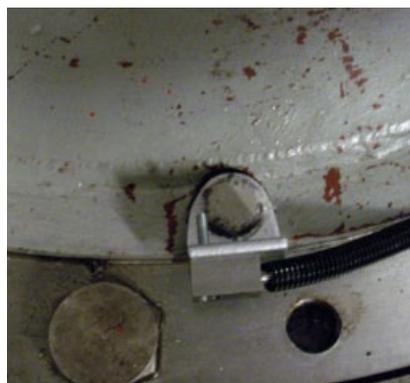
Figure 6. Examples showing the accelerometer installation, highlighting the ease of installation and maintainability on the turbine bearing (Brüel & Kjær Vibro AS 0070/02 accelerometers are used). The accelerometers are shown mounted on the turbine bearing casing, with one in the X direction (right) and one in the Y direction (left). The generator bearing (not shown) is mounted with one X radial and one Z direction axial accelerometer, 90 degrees apart.

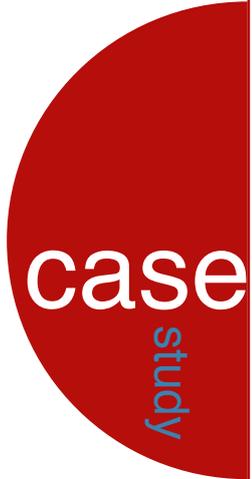
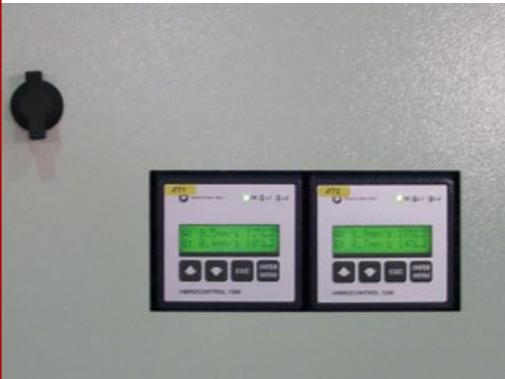
Figure 7. Cabinet installation for the two VC-1500 vibration monitors.

plier function in the VC-1500 prevents tripping the machine when high vibrations occur due to start-up/synchronization. Data display and system control can be undertaken locally or by a PC server via a USB/CAN bus interface. The two VC-1500 monitors are typically installed in a cabinet close to the generator in the power station, as shown in Figure 7.
