uptime magazine

Q3-13

LDPE Reactor mixer bearing faults – Part 1

String Testing a Typical Machine Train – Part 2

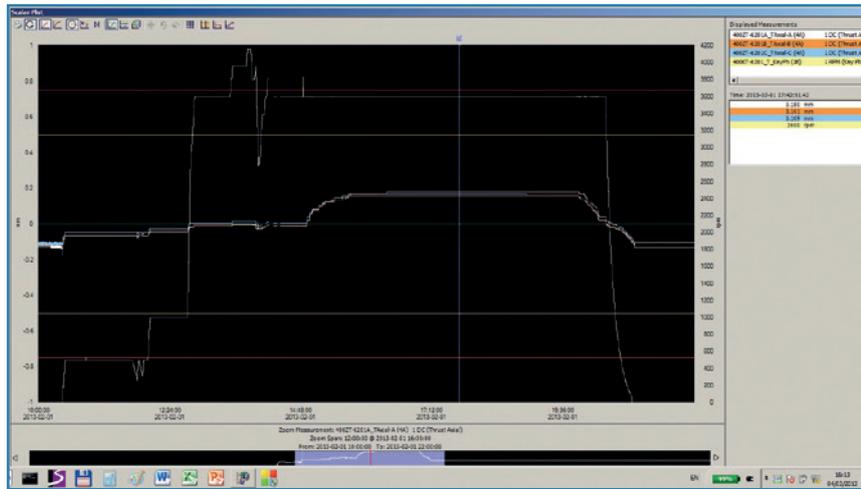
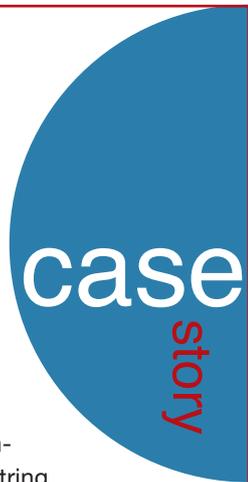
Figure 4. Axial position (top) and radial vibration (bottom). These critical measurements are monitored across all machine states during the complete string test period. The axial displacement measurement is especially important since a thrust bearing rub could result in catastrophic damage to the machine within a few short moments.

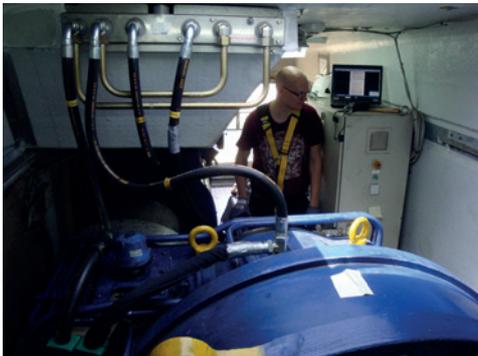
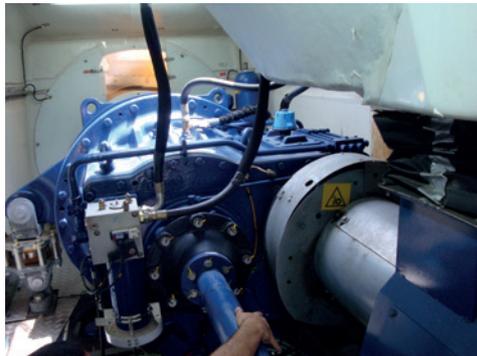
Figure 1. Site survey for installing the monitoring system hardware and sensors in the different types of wind turbines (left to right: Gamesa Type 1, Gamesa Type 2).

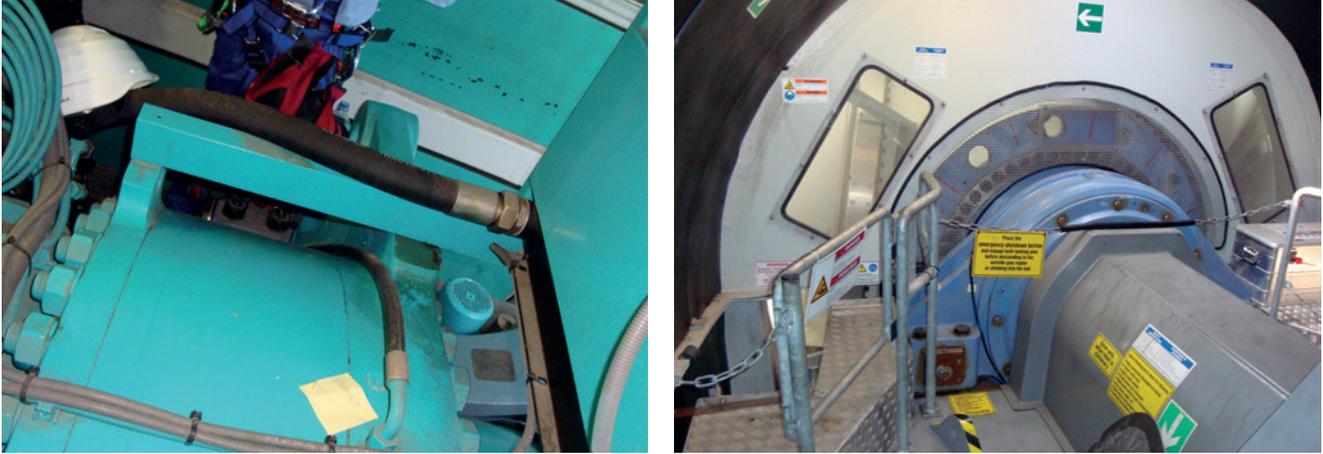
Figure 2. Site survey for installing the monitoring system hardware and sensors in the different types of wind turbines (left to right: GE 1.5 S, Repower).
