# APPLICATION NOTE

## Effective off-line machine fault detection and diagnosis at the Tabriz Petrochemical Complex

### Case Study - Multiple faults

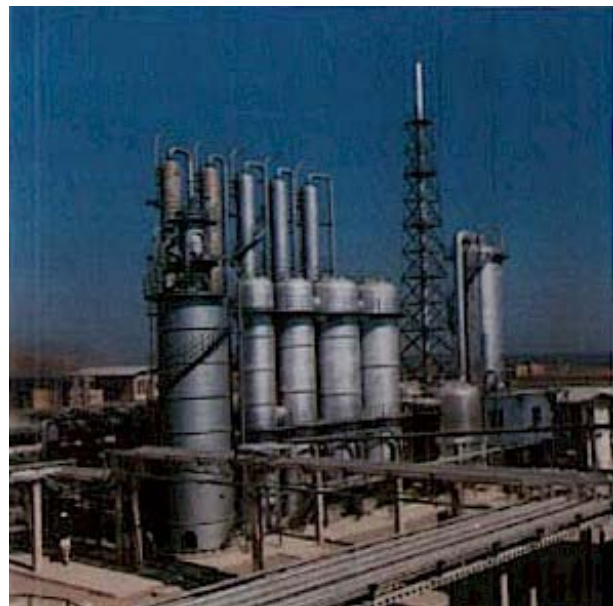
For several months the vibration velocity rms value for this pump was within the VDI 2056 limits (maximum of 1.98 mm/s), but during a routine monitoring round, there was a sudden increase to 7.8 mm/s. Diagnostic measurements were then immediately done using FFT spectra and BCS (bearing condition signature/selective envelope detection) to find out the cause of the high vibrations.

Fig. 1 Motor-driven centrifugal pump in water pre-treatment plant

After disassembly, it was observed that rubber pads of the coupling were damaged. After replacement, measurements were done again and the overall vibration decreased to 1.8 mm/s, which was acceptable. The FFT measurements also looked better (Fig. 4). Although the pump was now fully operational, further investigation was still needed to

Investigations revealed that a 2" line was welded from the suction end of the pump to discharge header to satisfy process requirements two weeks earlier. This caused piping strain that misaligned the shaft and later damaged the coupling. If this

situation was not corrected in time, severe damage could have occurred to the motor and/or pump that could have resulted in both lost production and expensive spares. Since this problem was corrected, the pump has been functioning well the last eight months.

A work order was issued to Maintenance to immediately align the pump shaft and check the condition of the coupling. An envelope spectra suggested that although there was severe misalignment, there was no apparent consequential damage to the rolling-element bearings so these did not have to be replaced or even checked.
