CASE STUDY

Detection of High-Speed Coupling Looseness

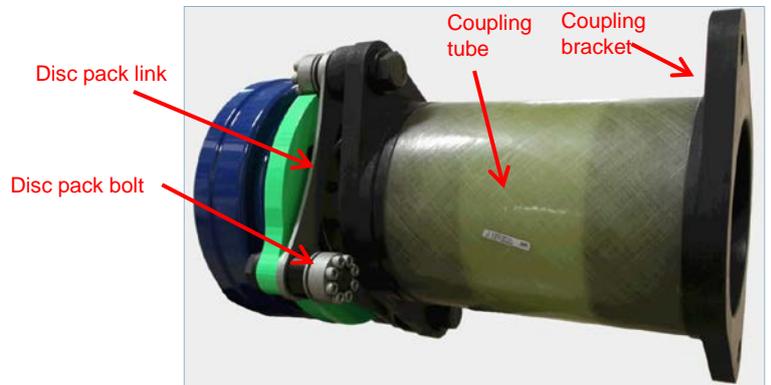
Figure 1: High-speed coupling of a wind turbine showing the flexible disc pack link structure on the left (gearbox side). The disc pack on the right (generator side) have been removed for clarity. Some high-speed couplings have an eccentric composite disc instead of the disc pack link structure.
