## YAW BEARING SYSTEM FAULT DETECTED

Two case studies demonstrate how an effective remote condition monitoring strategy avoids uneconomical operation, costly downtime and consequential damage of wind turbines

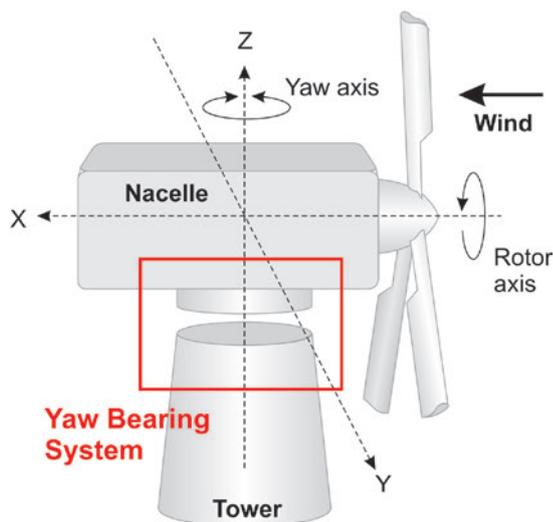
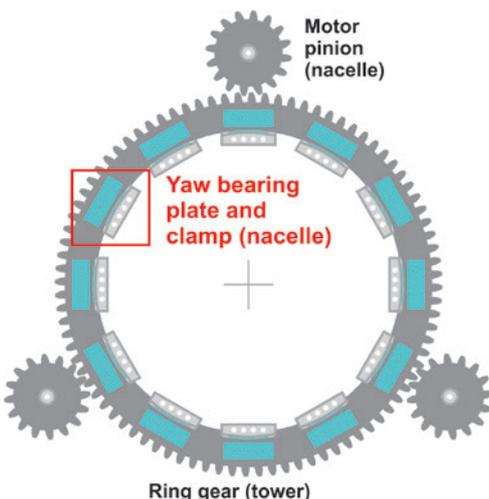
The system consists of a toothed ring gear that is fixed to the tower (Figure 1, bottom). Yaw motors turn several pinion gears on the ring gear to rotate the nacelle. The load bearing components consist of axial and radial glide bearing pad segments that sit on the ring gear, as shown in Figure 1 (bottom). The bearing pad normally includes a pre-tensioning system, which consists of a spring and an adjustment screw, as shown in Figure 2. This ensures that there is no looseness between the glide bearing segments and the ring gear, and that there is even wear on all the guide bearings. If the glide bearings are not properly pre-tensioned, this can damage the glide bearings and adversely affect the ability of the nacelle to turn.

**Figure 1.** The yaw bearing system on a wind turbine (top) aligns the blades to the wind. It consists of the ring gear, yaw motor and the yaw bearing clamp assemblies (bottom, looking down from the nacelle).

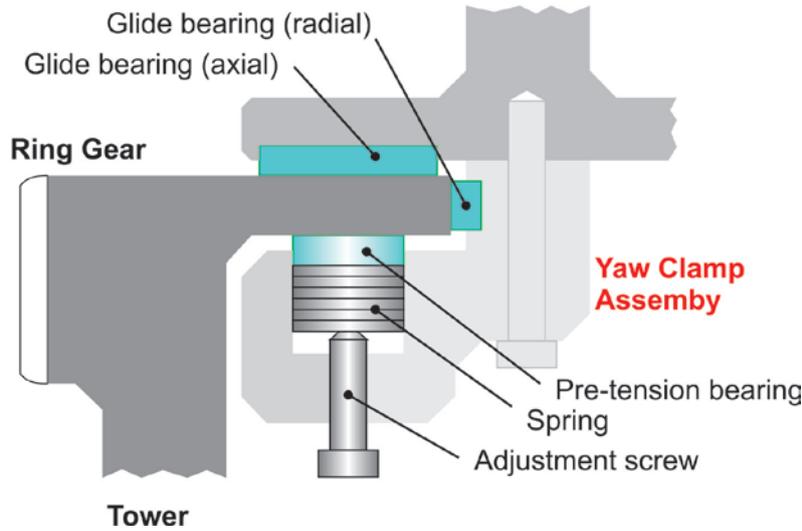
**Figure 2.** Cross-section of the yaw clamp assembly on the ring gear.

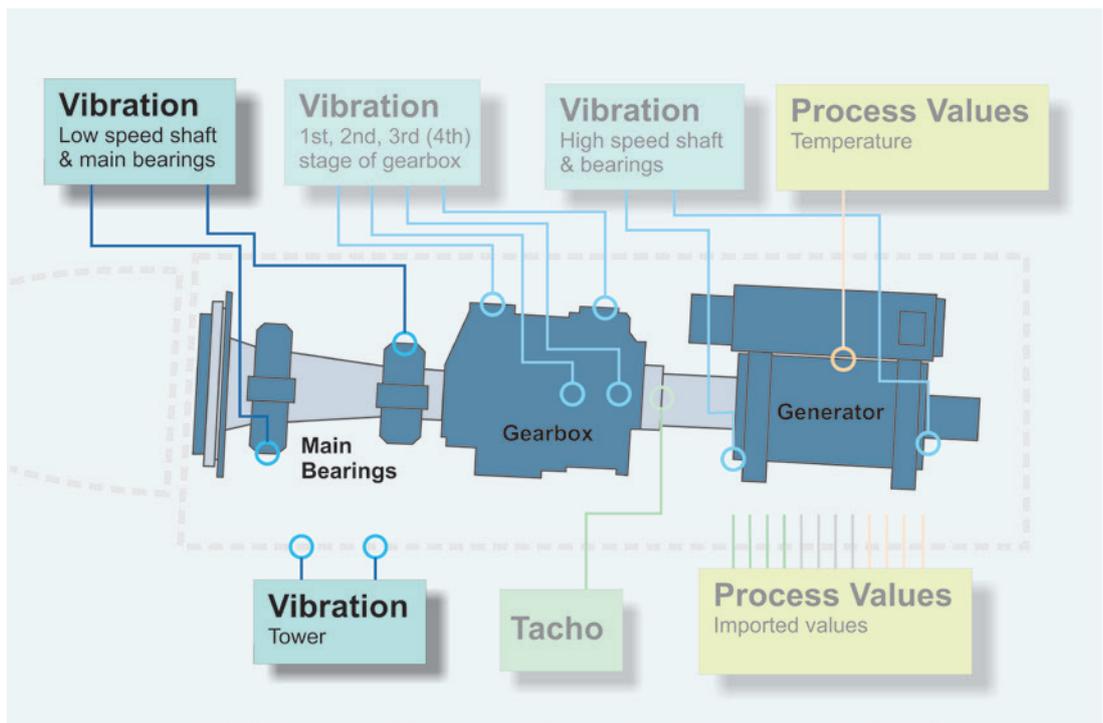
The Brüel & Kjær Vibro Surveillance Centres have been remotely monitoring many different kinds of faults, but these two cases were unique. The monitoring system configuration for detecting the faults is shown in Figure 3.

**Figure 3.** Typical monitoring strategy for a wind turbine like the one in this case story. The accelerometers located on the tower and the main bearing detected the yaw bearing system fault.
