RUN LIKE CLOCKWORK

Michael Hastings, Brüel & Kjær Vibro, Denmark, explains how early detection and diagnostics of bearing manufacturing faults and improperly assembled gearboxes is vital for the smooth running of critical machines at LNG plants.

Case 1 – bearing with manufacturing fault detected on instrument air compressor

Case 2 – detection of improperly assembled gearbox of the propane compressor

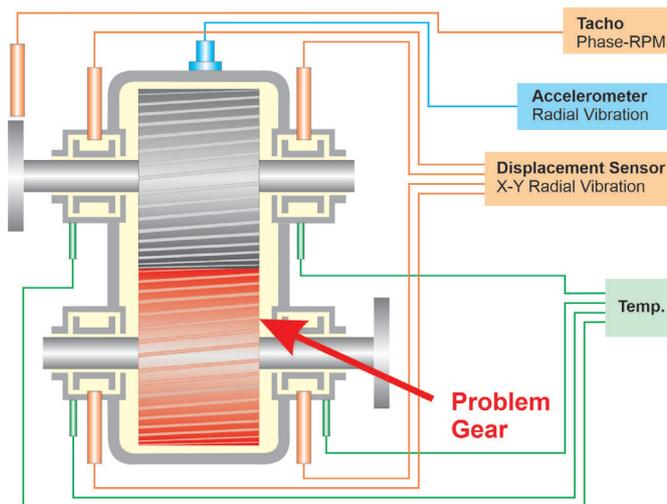
The gearbox, like the rest of the propane compressor train, is extensively instrumented for protection, condition, and performance monitoring. As shown in Figure 3, X-Y displacement sensor pairs are mounted on each of the bearings of the gearbox.

Figure 3. Sensor configuration for the propane compressor gearbox.
